Tank Failures – Causes and Prevention

Fluid Technology Roundup

Fluid Fertilizer Foundation

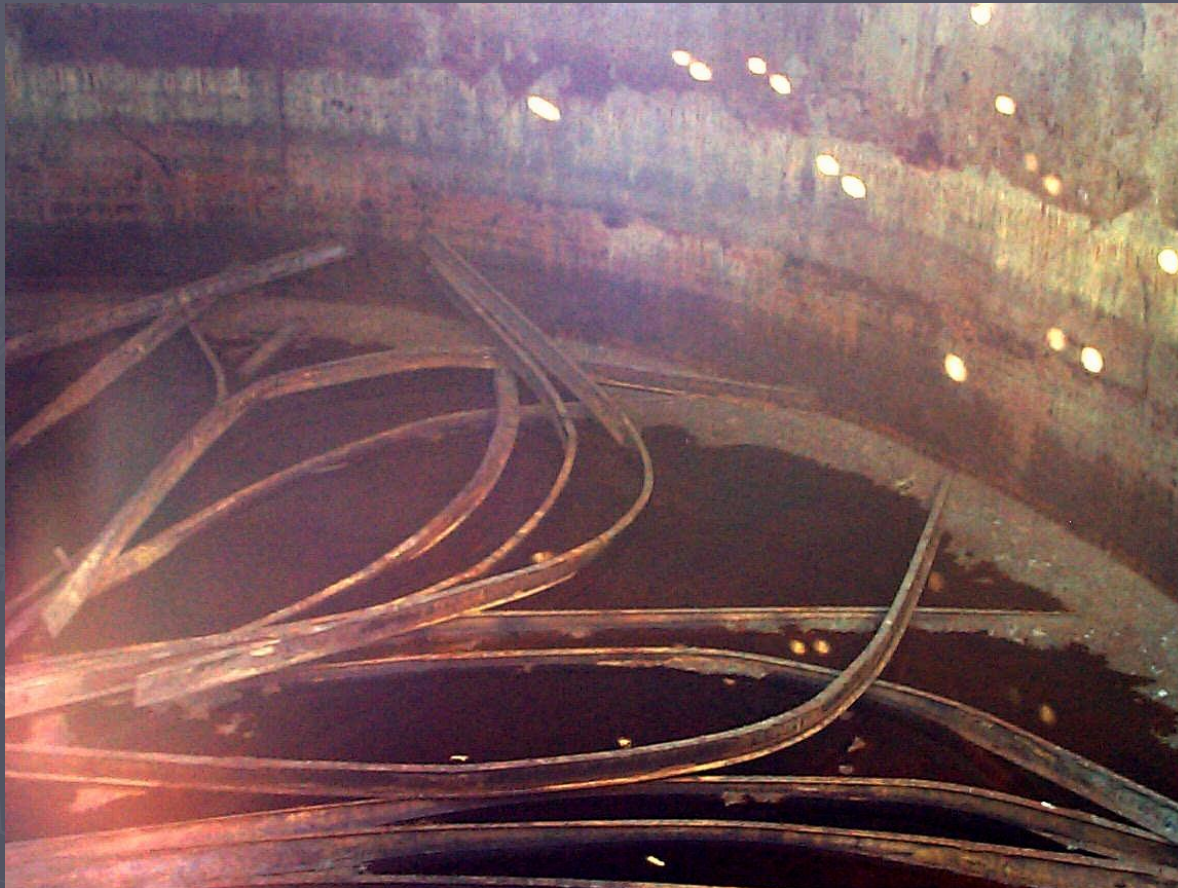
Roof Failures

- ▶ Internal Beam Failure
- ▶ Corrosion due to build up of moisture, acids, salts, etc.

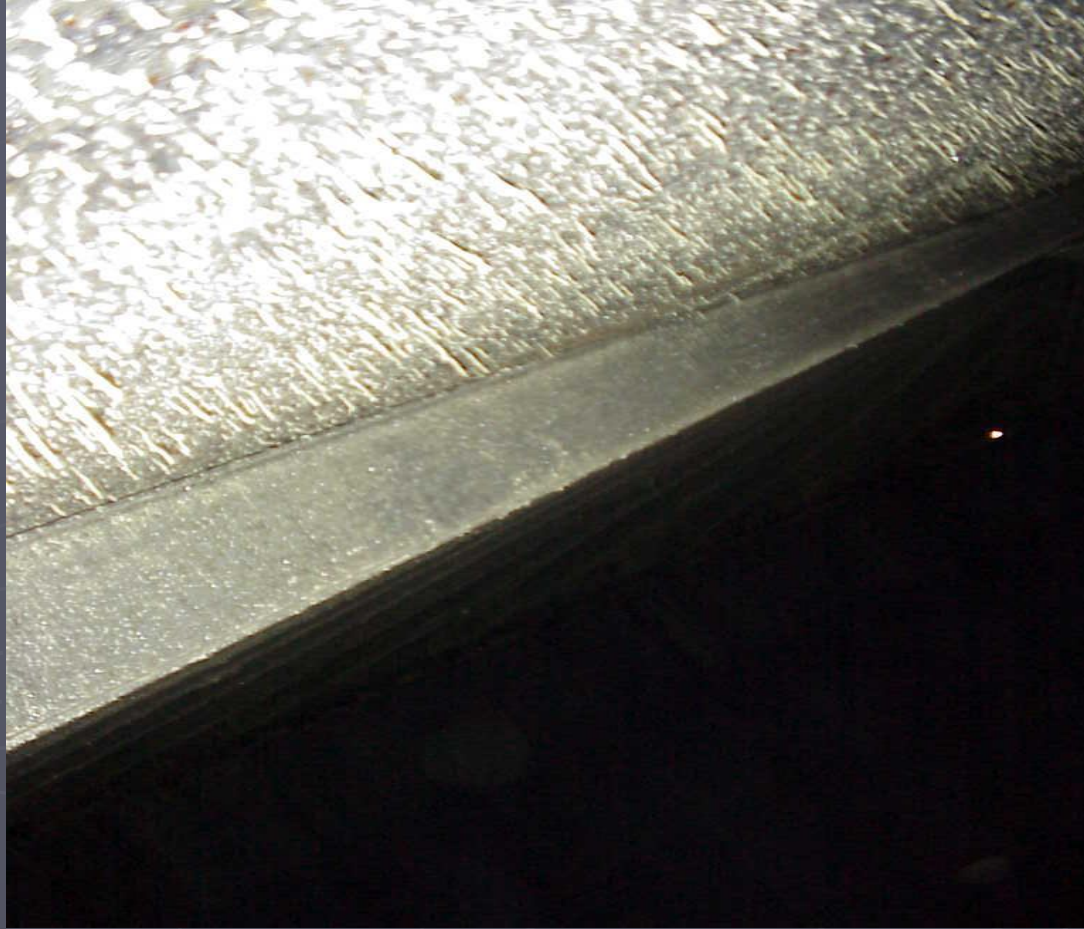
Roof Failure

Build up of solids which are acidic in nature on internal of tank roof

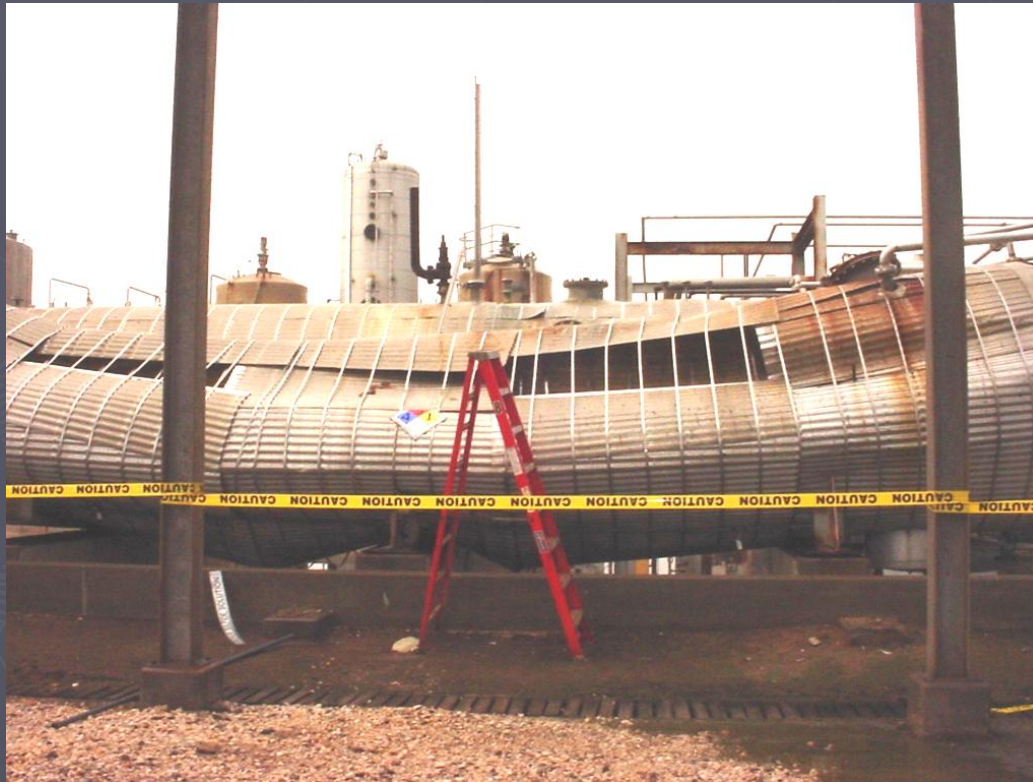
Roof Failures

- ▶ Vent Failures – a plugged vent can cause vacuums or overpressure to damage tanks

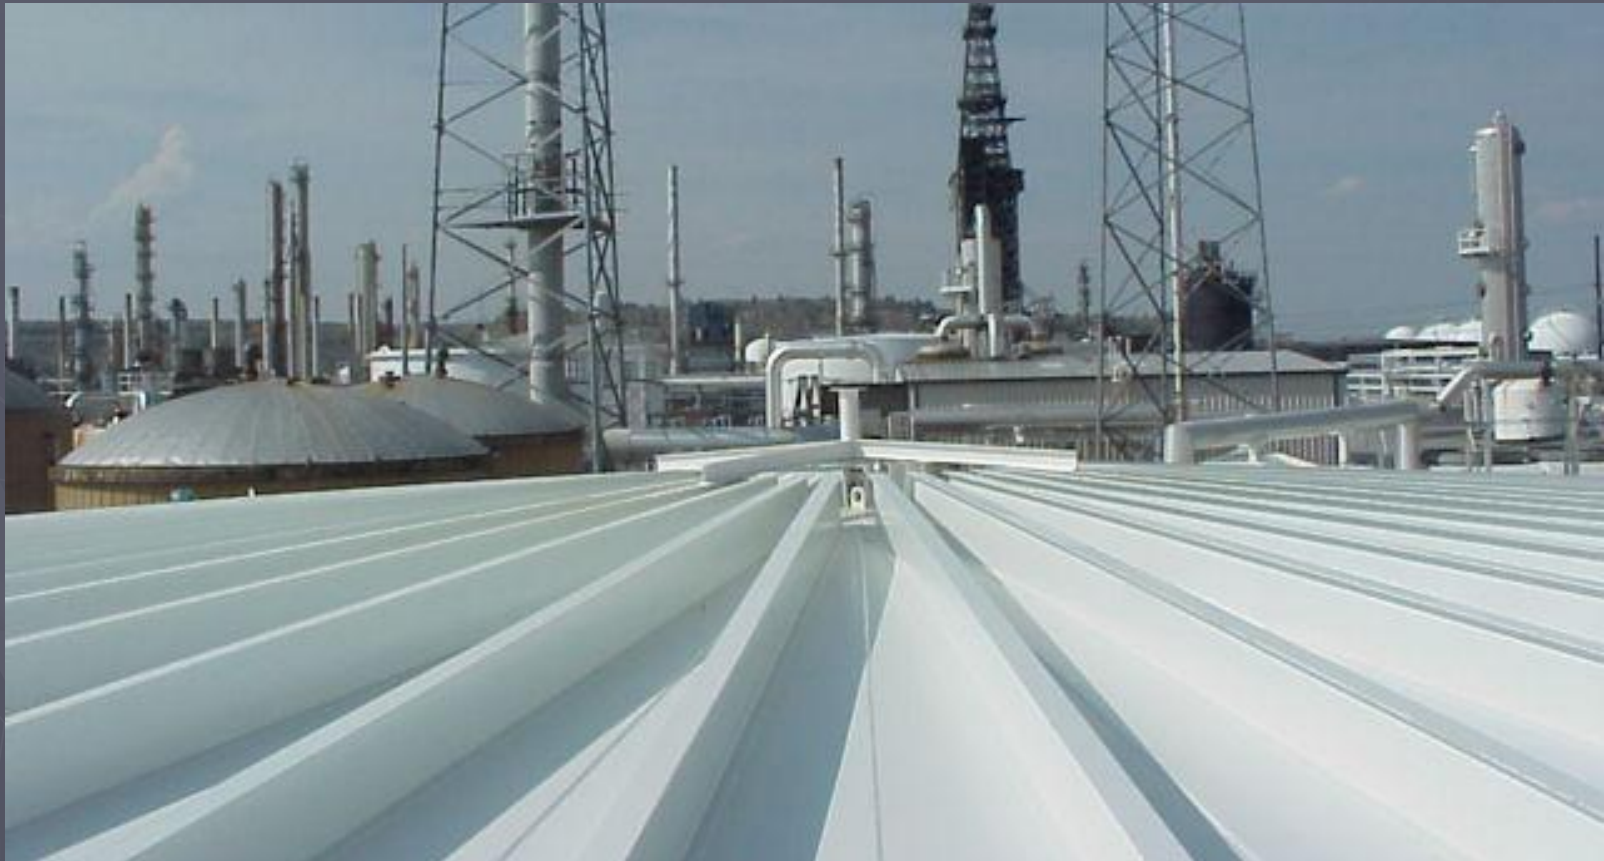
Roof Failure Prevention

- ▶ External Rafters, nitrogen blanketing, coatings reduces corrosion likelihood

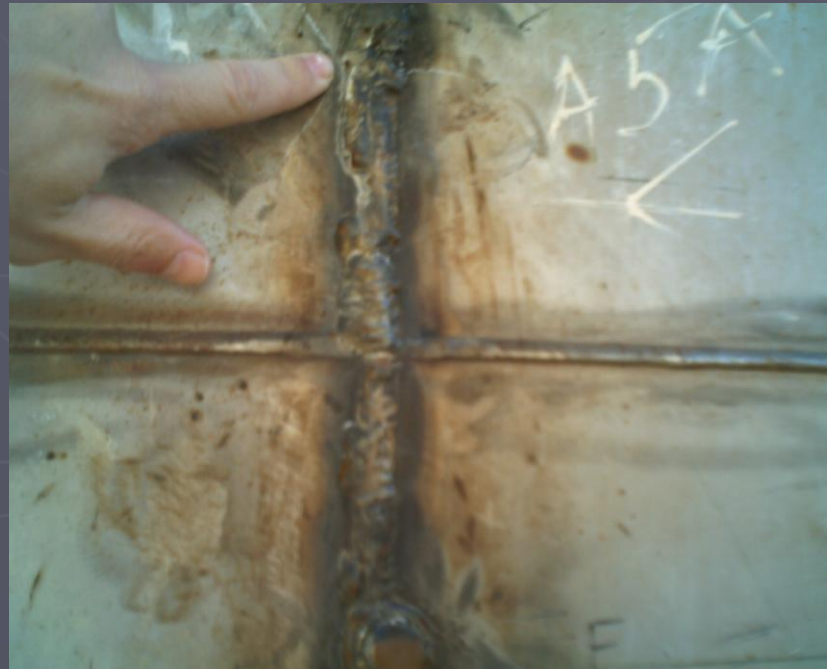
Wall and Weld Failures

- ▶ Poor welding procedures are main culprit on weld failure
- ▶ Specific gravity of liquid too heavy for tank's wall thickness
- ▶ Corrosion – pitting, cracking, general thinning can cause loss of containment

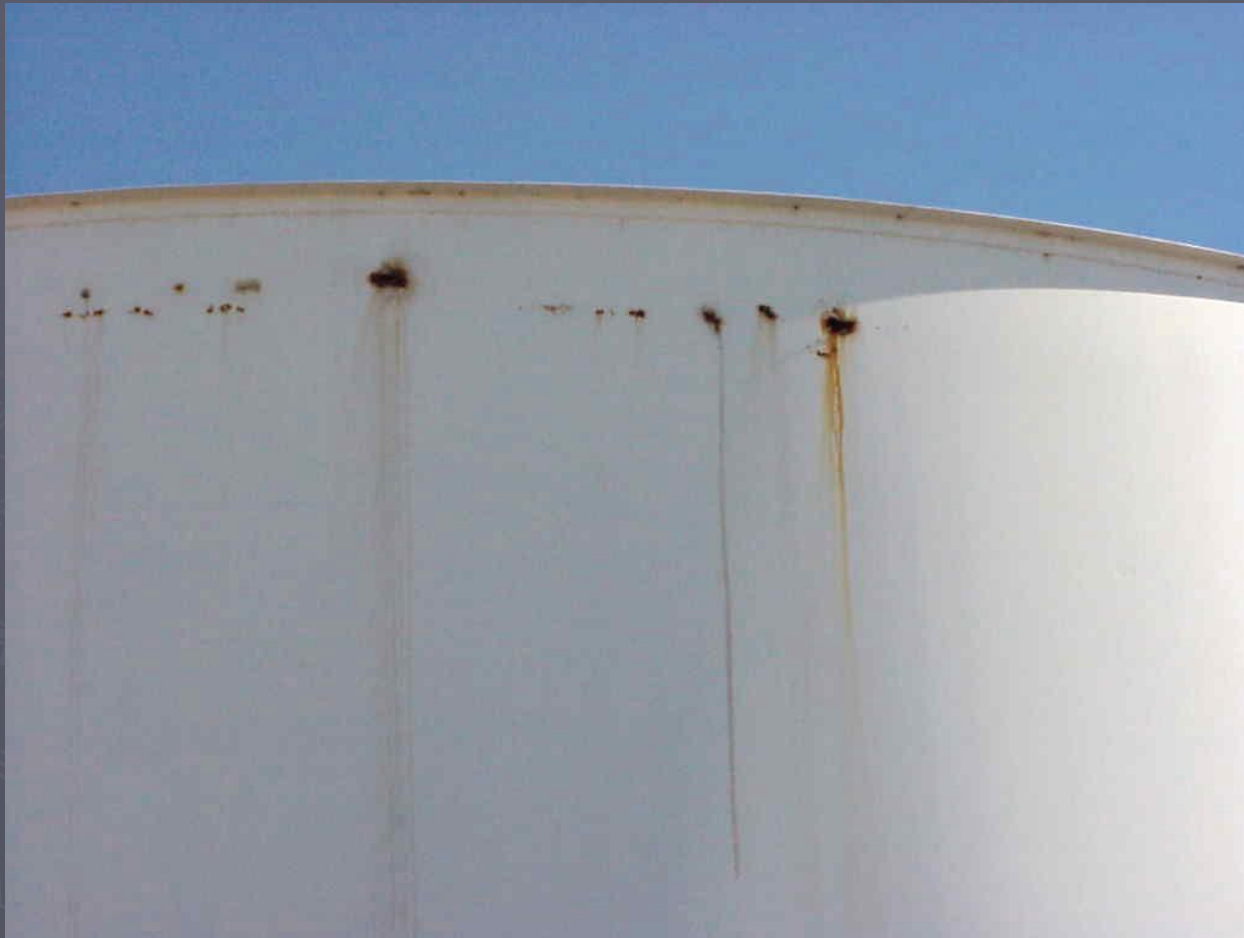
Weld and Wall Failure

This failure occurred just above a bladder on the SOUTH side of the tank only – daily temperature fluctuations contributed to accelerated corrosion

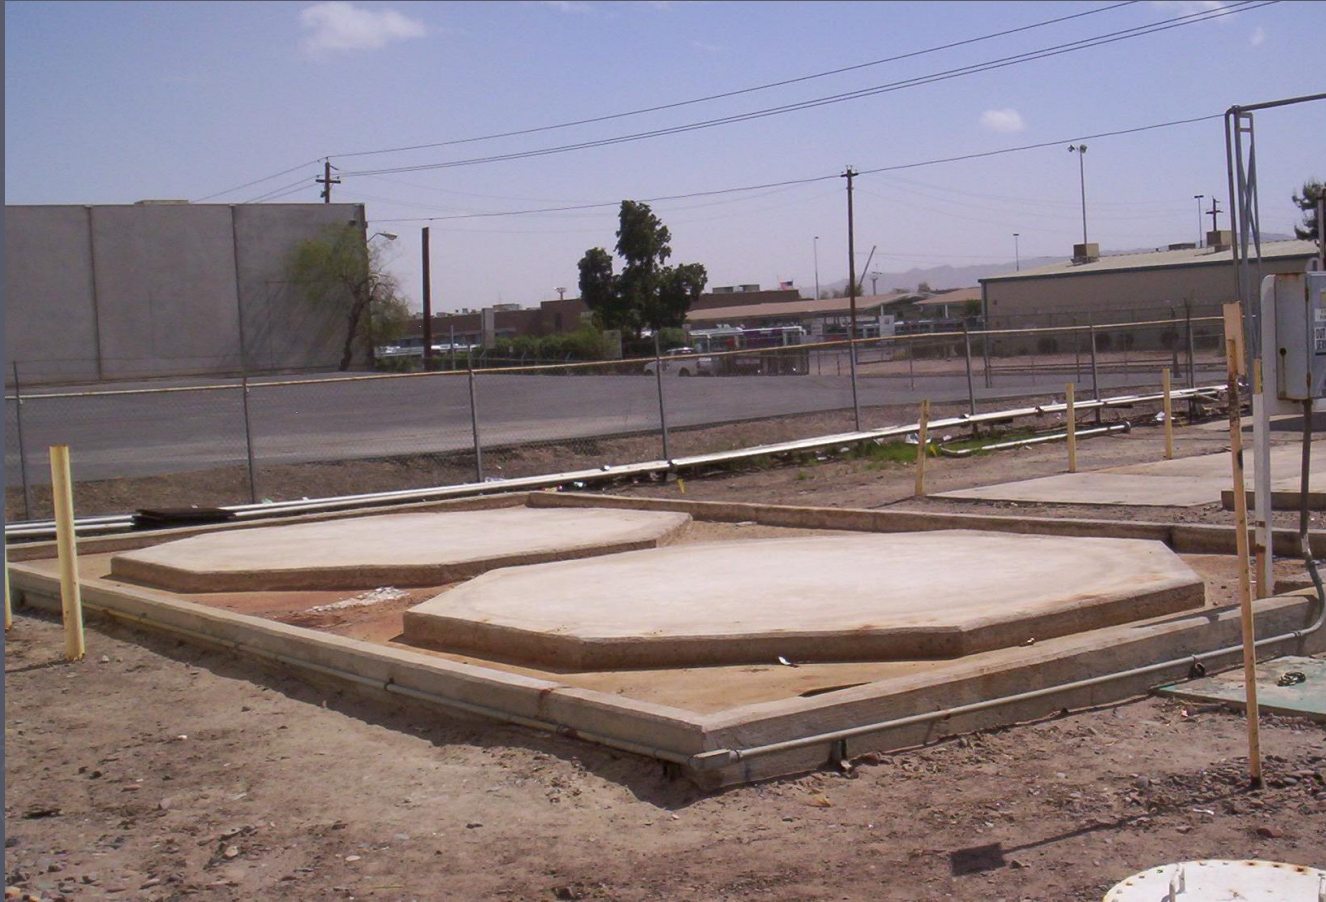
Floor Failure Prevention

Foundation for new tanks

- ▶ Concrete Foundations
- ▶ Internal Coatings
- ▶ Full draining of liquids/thorough circulation of liquids
- ▶ Routine solids removal
- ▶ Cathodic protection
