By Dr. Craig Myers, Senior Research Scientist and Phil Bureman, Industry Technical Consultant

Agenda

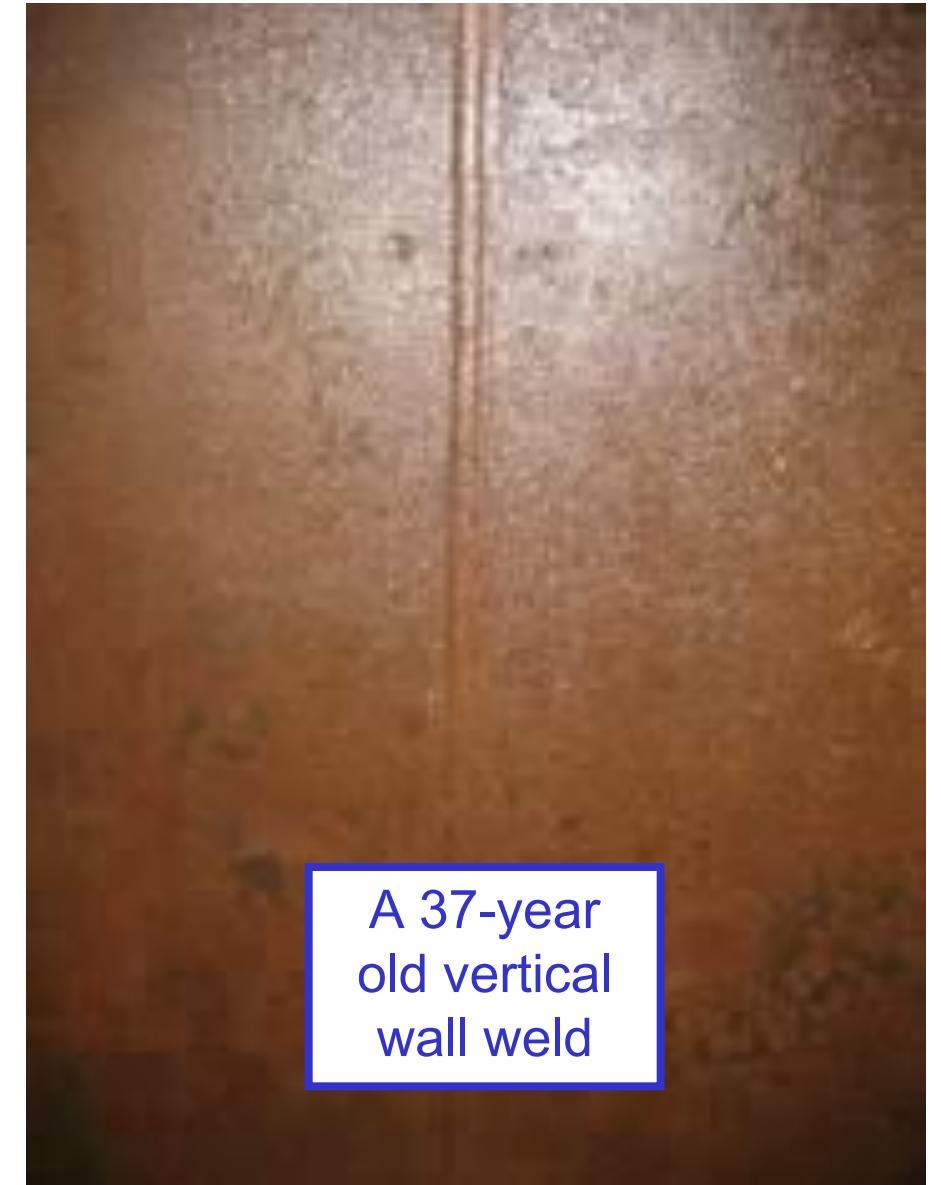
Typical Vertical Surface Appearance

- Vertical weld zones typically show no damage at all
- Note that sludge is unable to accumulate here

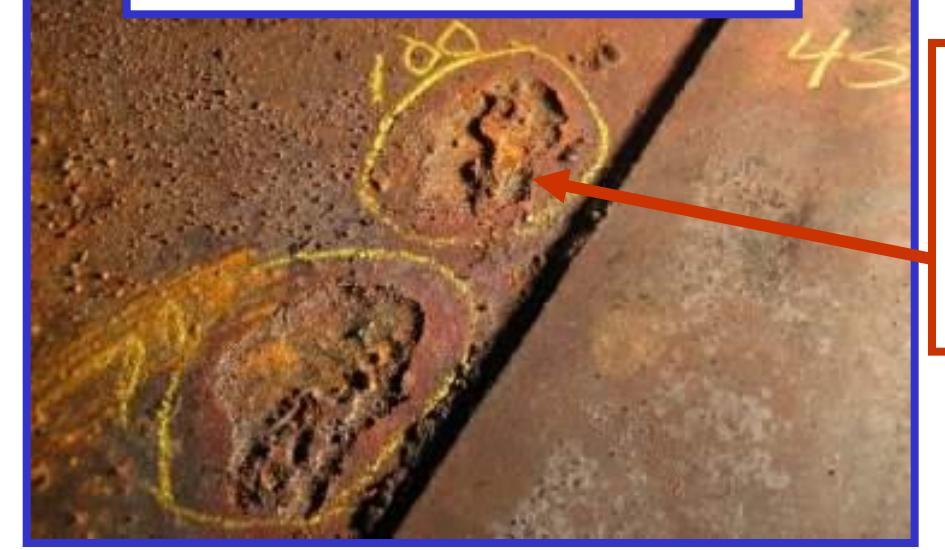
Plate thickness ranges from 1/4" to 1/2" with 3/8" the most common, so 100 mil pits are very significant. Moderate/Severe Corrosion

Damage always on lower edge of lap weld

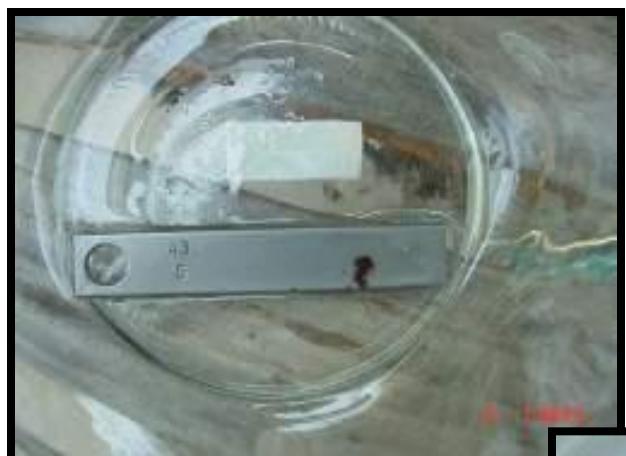
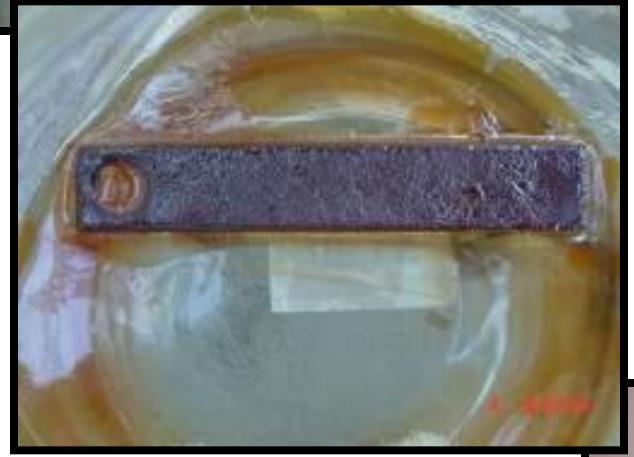
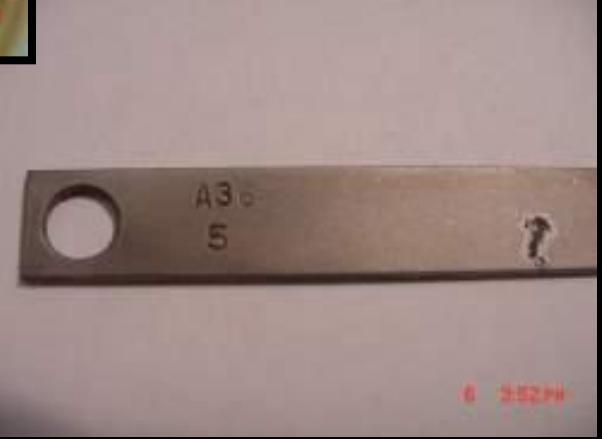
Surface Corrosion & Sludge Formation in UAN

- A corrosion coupon was put in a jar with a small amount of UAN 32.
- The jar was sealed for 7 days in bright sunlight (the coupon had the existing corrosion spot)
- No sign of <u>new</u> corrosion while sealed
- The jar was then opened ~ 3 hours and then re-sealed for 24 hours

Note the severe corrosion that developed on the coupon after the release of the ammonia

Key Take-Away: A little bit of "surface corrosion" creates a lot of sludge!

However, this severe corrosion was easily wiped off with a paper towel and the original corrosion spot remains

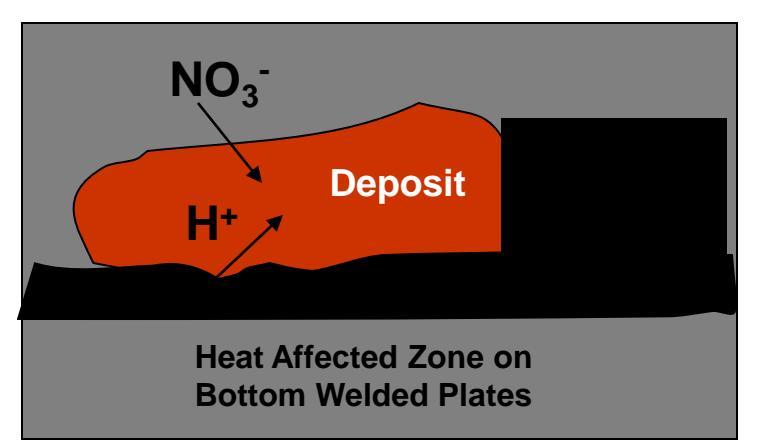
NH₃ NH₃ NH₃ UAN "Thin Film" VUAN "Thin Film" Bulk UAN @ Vertical Wall Pitting Corrosion in UAN Crevice or Under-Deposit Corrosion

Fe⁺² → Fe⁺³

$Fe^{+3} + 3H_2O \rightarrow Fe(OH)_3 + 3H^+$

The H⁺ can't diffuse out of the crevice fast enough. To remain electrically neutral, NO_3^- ions come in and in effect make Nitric Acid resulting in low pH inside the crevice, resulting in accelerated (pitting) corrosion.

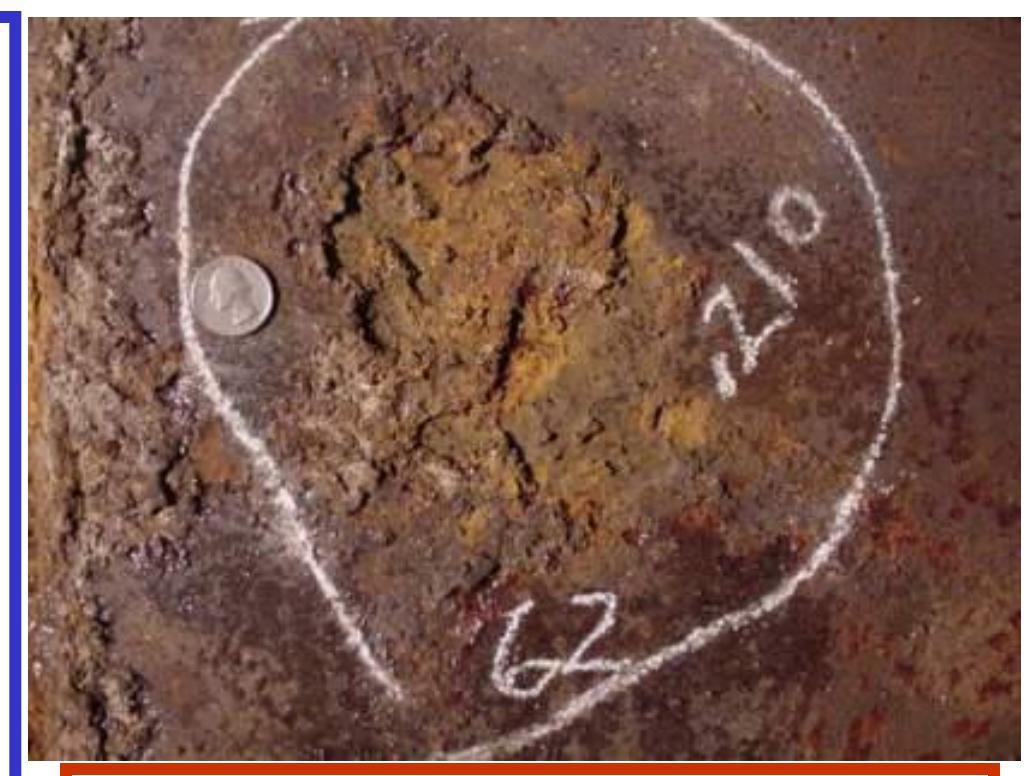
One operator did not open a tank for 17 years. By that time it had been leaking for over a year. The sludge from the tank filled two 30,000 gallon rail cars when it was cleaned out. It took over a year of wrestling with the state environmental board to be able to finally land apply the sludge to dispose of it. Even after extensive and expensive repairs, the tank floor had to be completely replaced 3 years later.

Sample 210 mil pit from corrosion underneath the deposits

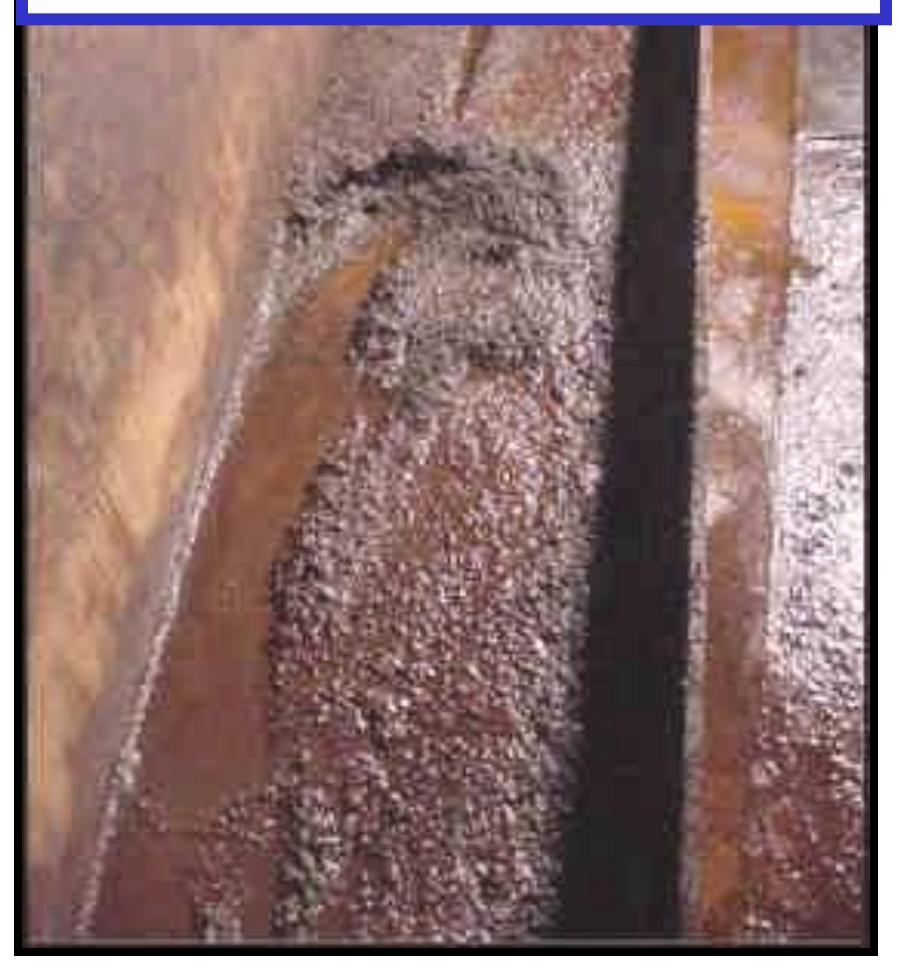
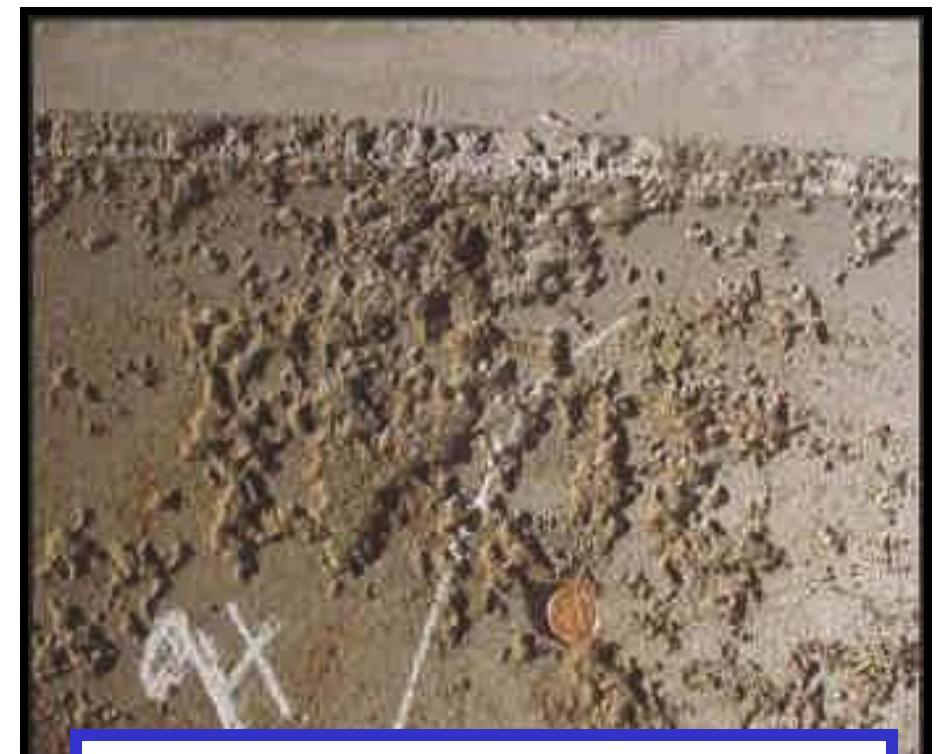
6" of Sludge Accumulated Behind Separator Ring in a NH3 Tank Converted to UAN Service

Resulting Corrosion Underneath the Deposits: 150 To 175 mil pits.

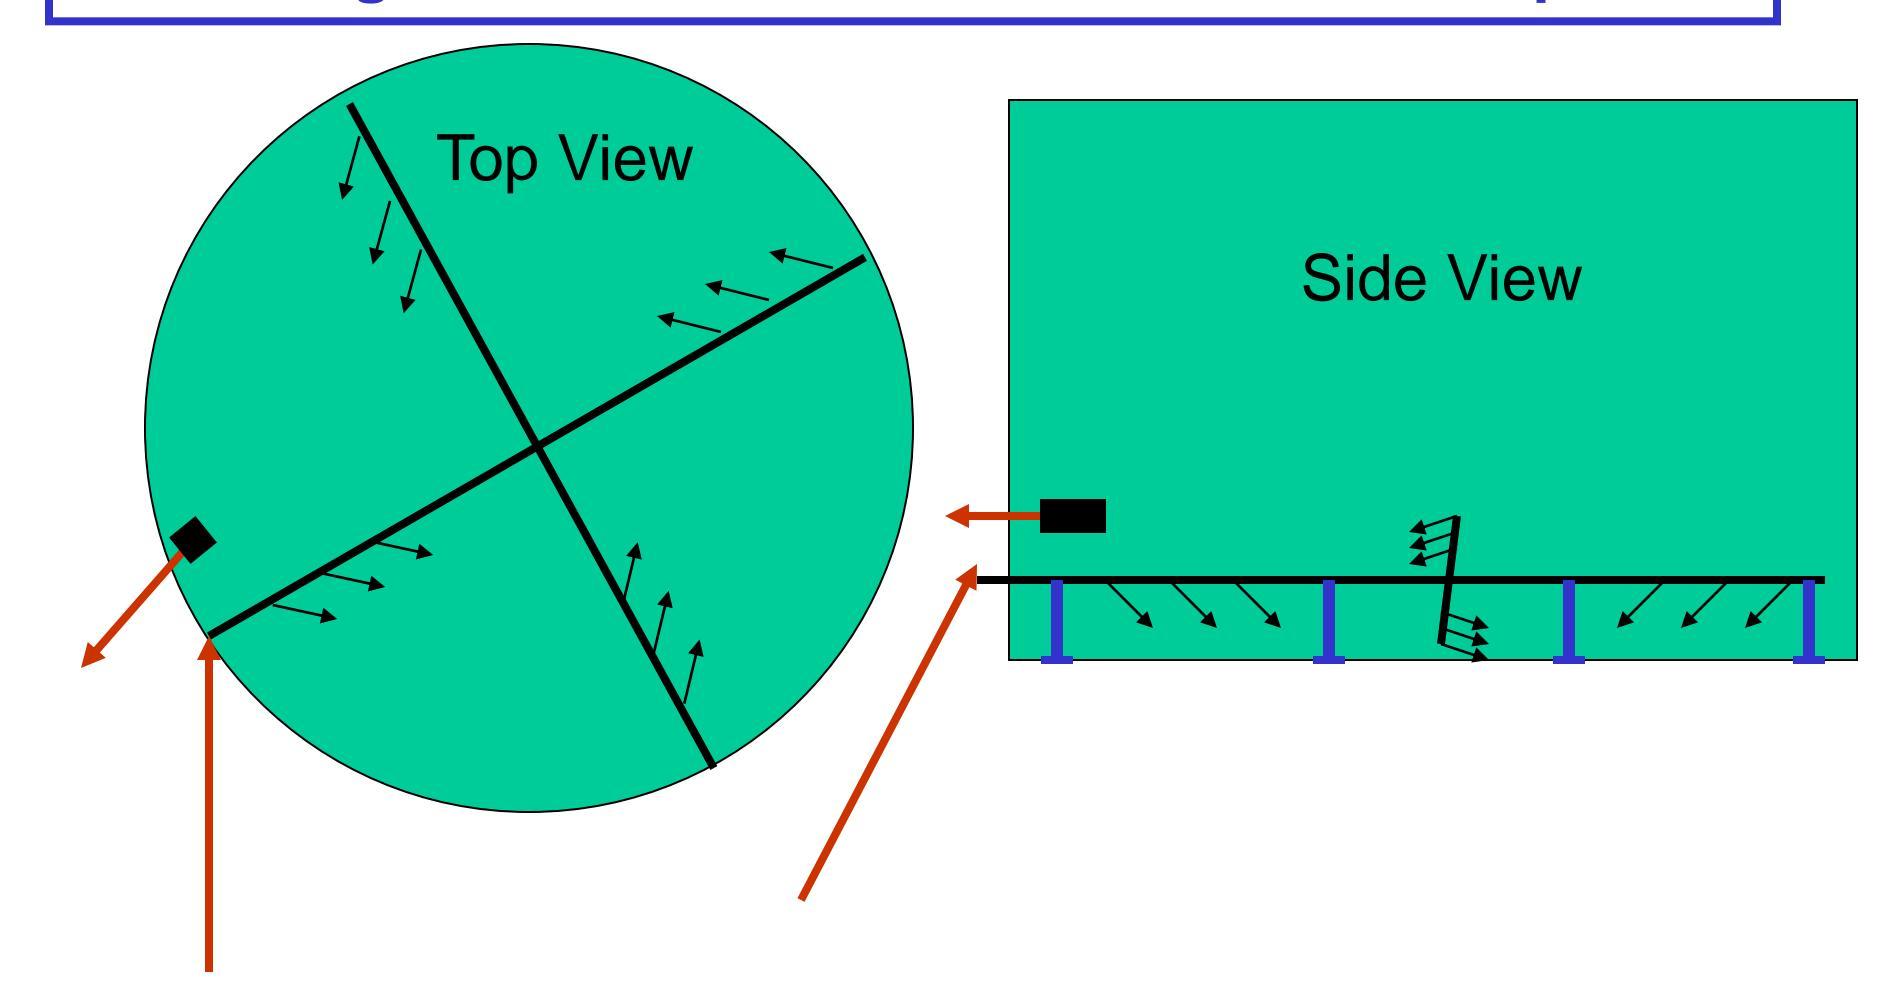
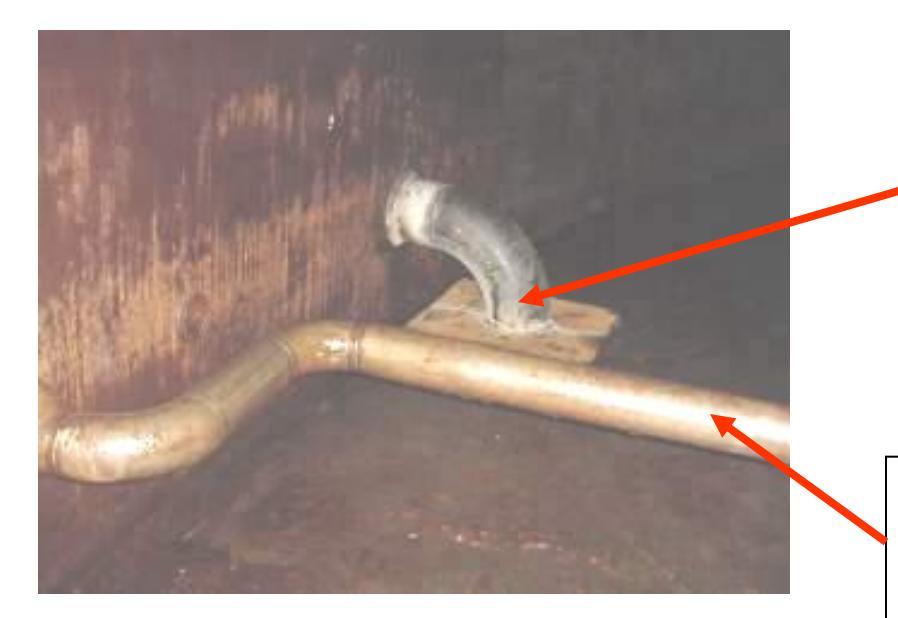
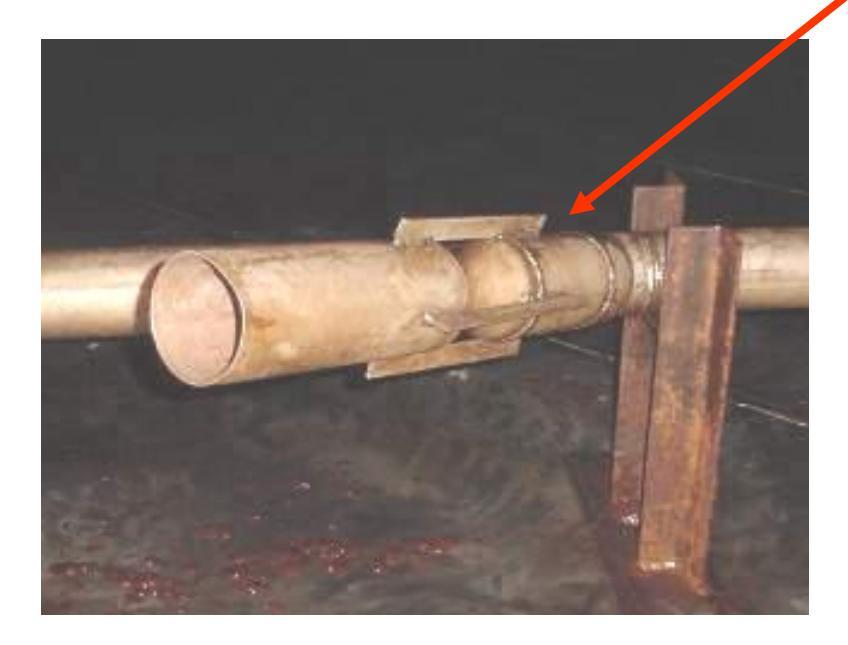
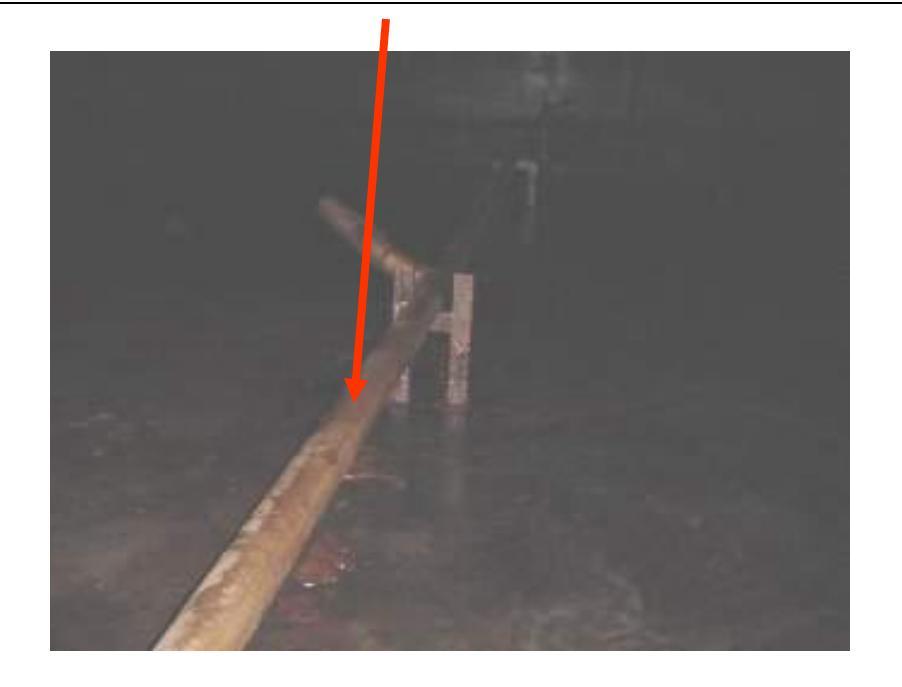
Design Improvements

UAN inlet pipe line header and outlet vortex breaker for UAN tank storage tanks, for prevention of sludge settling and inadvertent removal of tank tramp oil

Outlet Vortex Breaker: Prevents sucking out tank tramp oil.

Inlet Pipe and header with spouts that create tank circulation and helps prevent sludge settling.

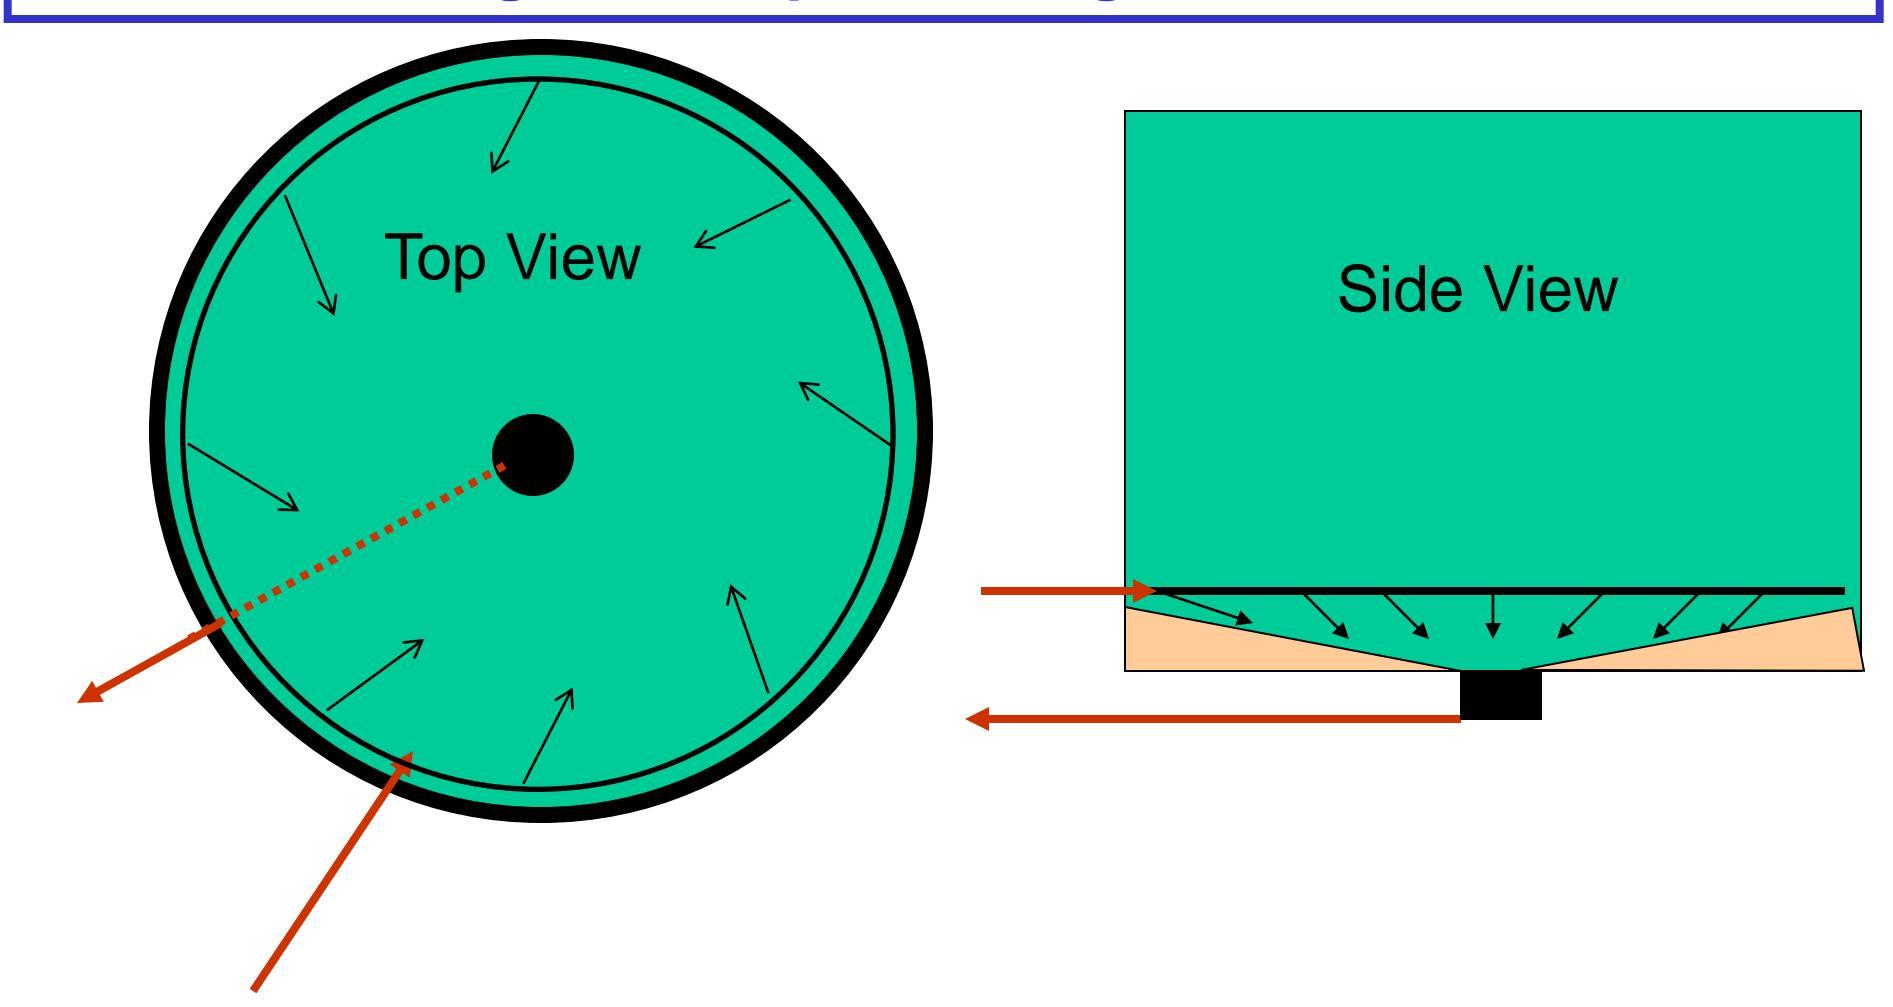
Optimum Tank Design

UAN circumferential inlet pipe line header with sloped tank bottom tank and center sump design to prevent sludge settling and keep it moving out of the tank

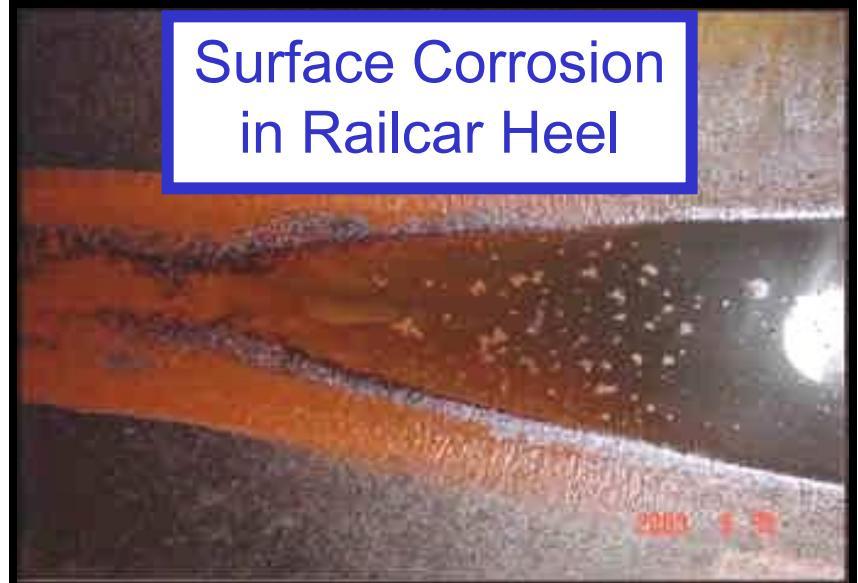
UAN Puddles Cause Surface Corrosion

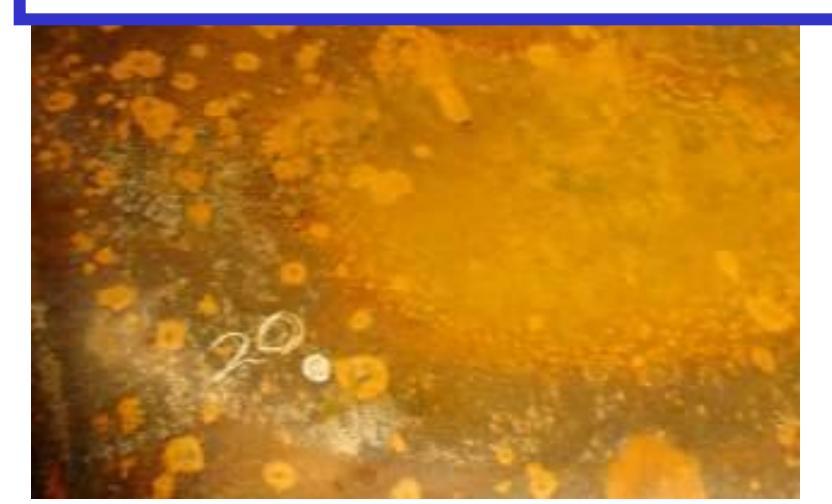
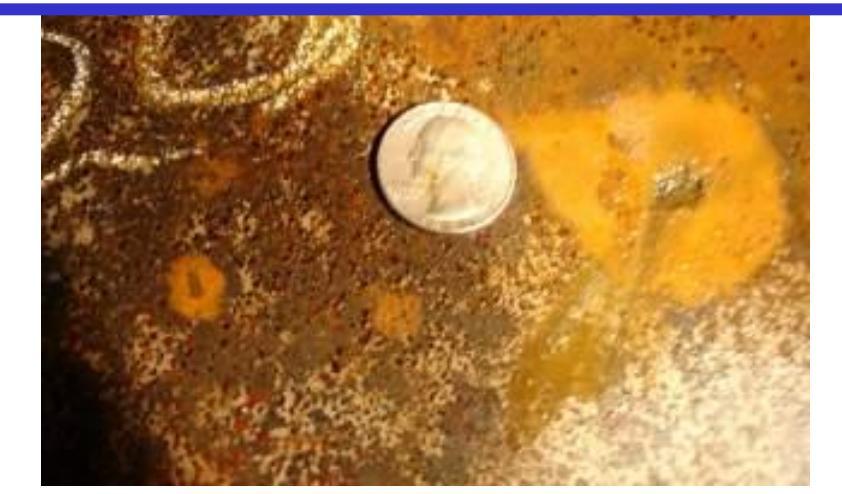
Followed by Pitting Under the Deposits

Pitting in Tank Bottom Left for Several Months with UAN Puddles

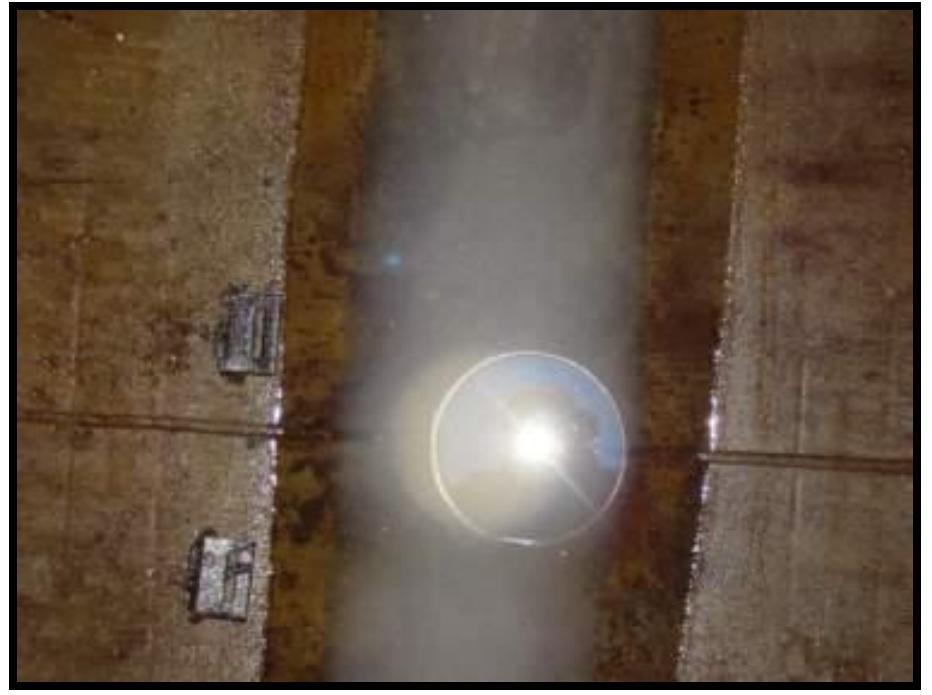
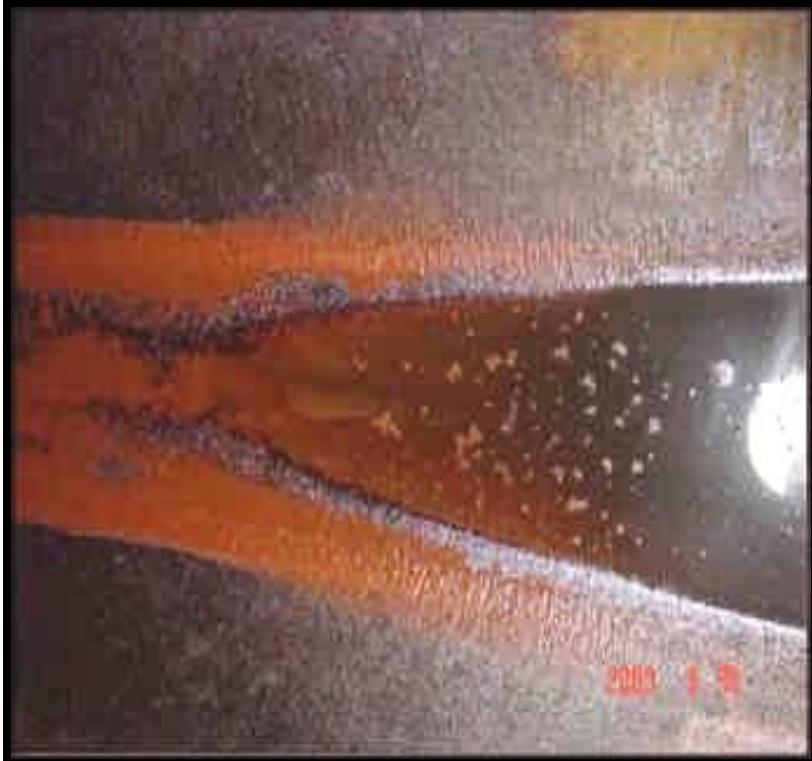
Organic-based "Temporary Corrosion Inhibitors"

UAN heel in UAN rail car: pre- treated surface

UAN heel in UAN rail car: surface NOT pre-treated

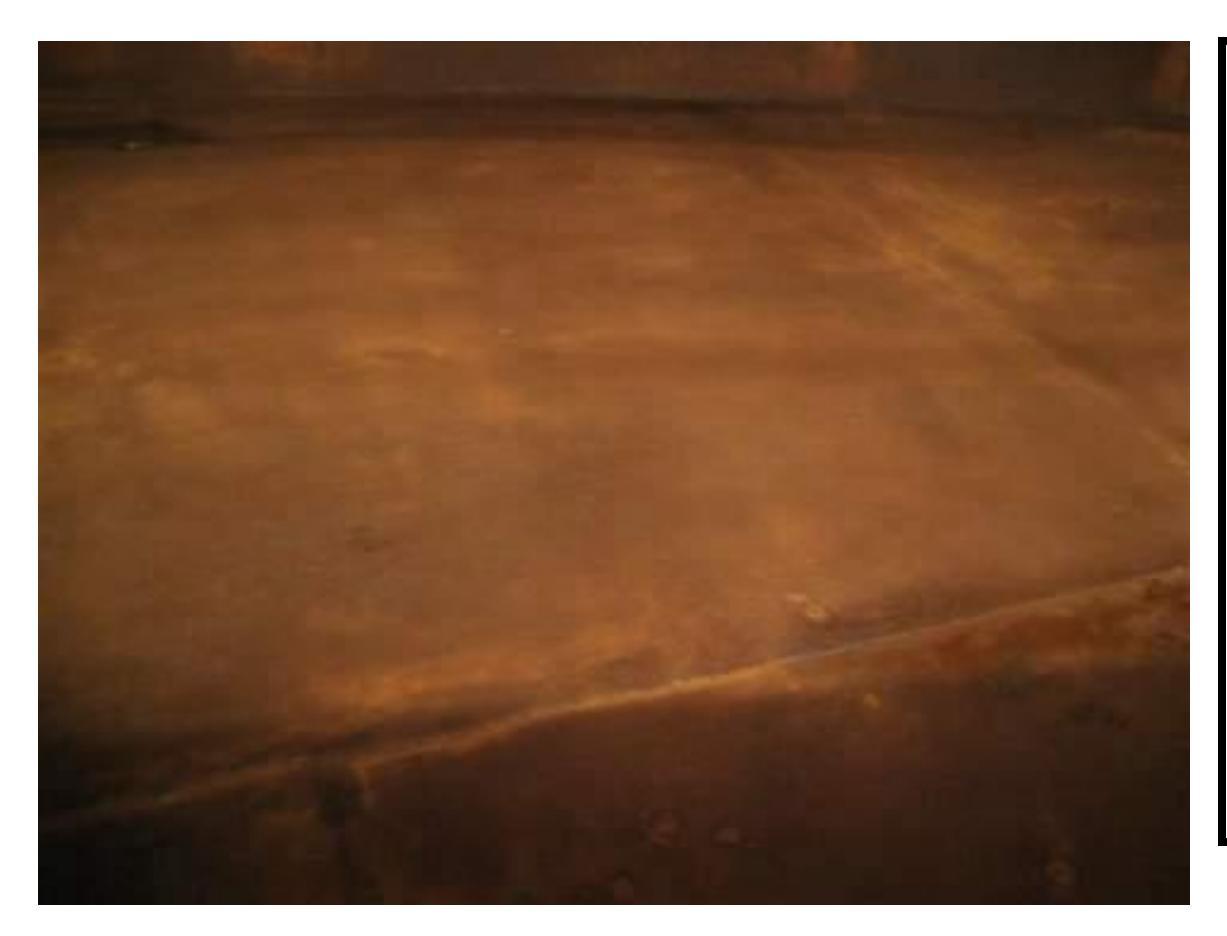
Inorganic Corrosion Inhibitor Treatment

Tank with a dusting of surface corrosion due to several months of inactivity was mopped with inorganic corrosion inhibitor before being put back into service. Doing so at start of idle would have been better.

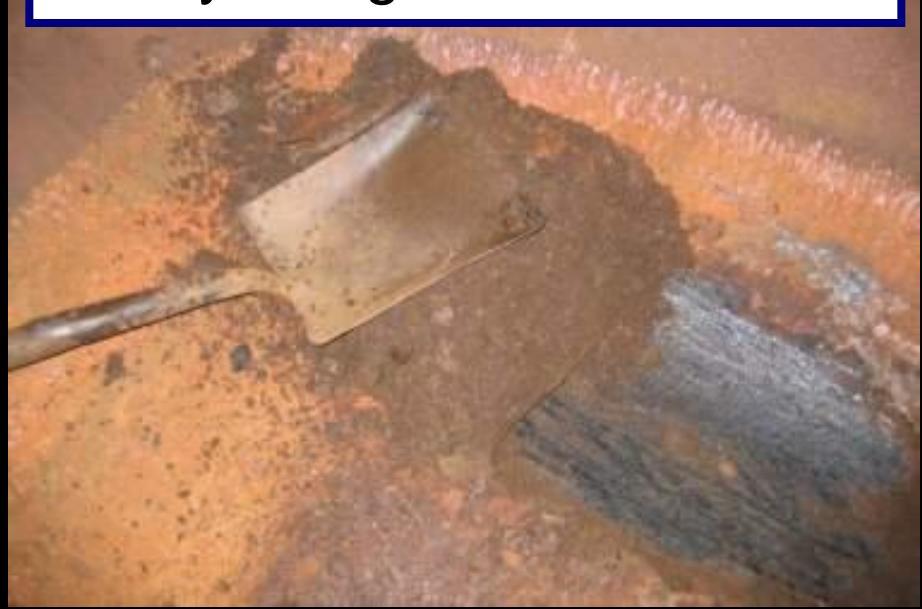
Heavy sludge in UAN rail car

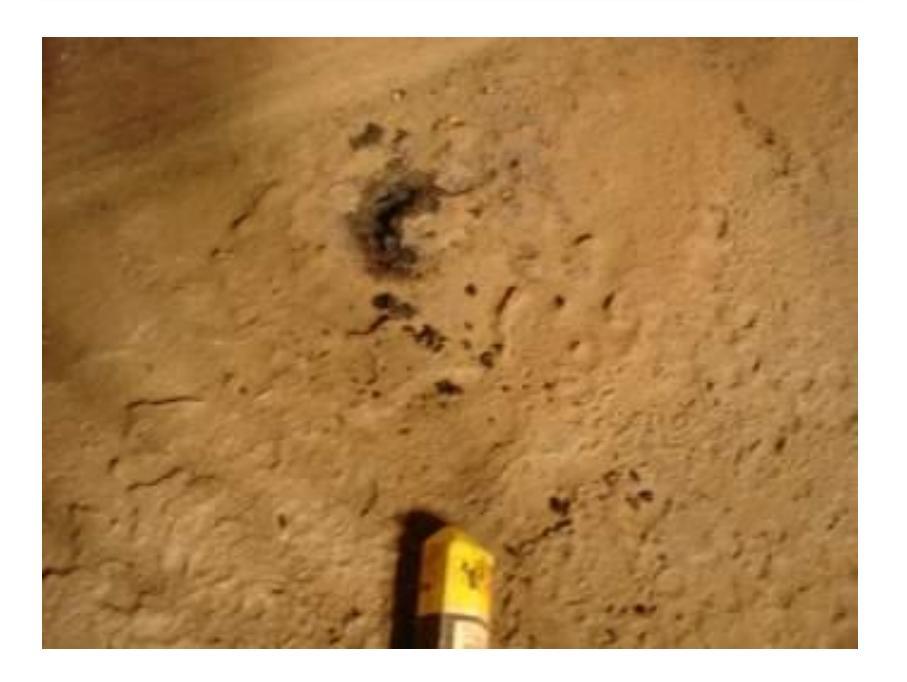
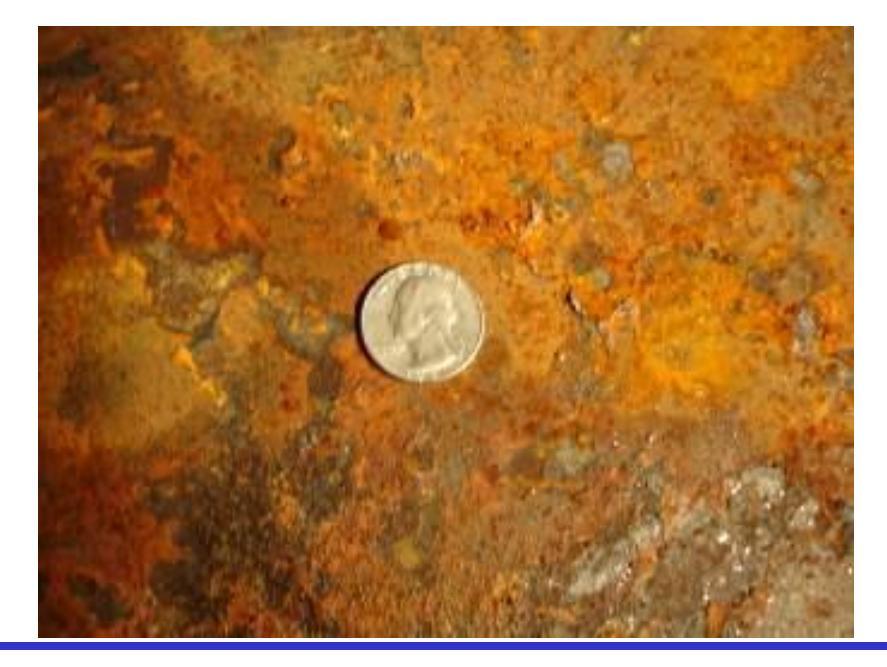
When Tank 2 was opened, as expected, the damage was massive and the floor was replaced. Leak near chine weld shown below.

But when Tank 3 was opened, it was found to have extensive sludge deposits and some damage as well. The iron that remained soluble (Fe⁺²) during the transfer had eventually oxidized and deposited.

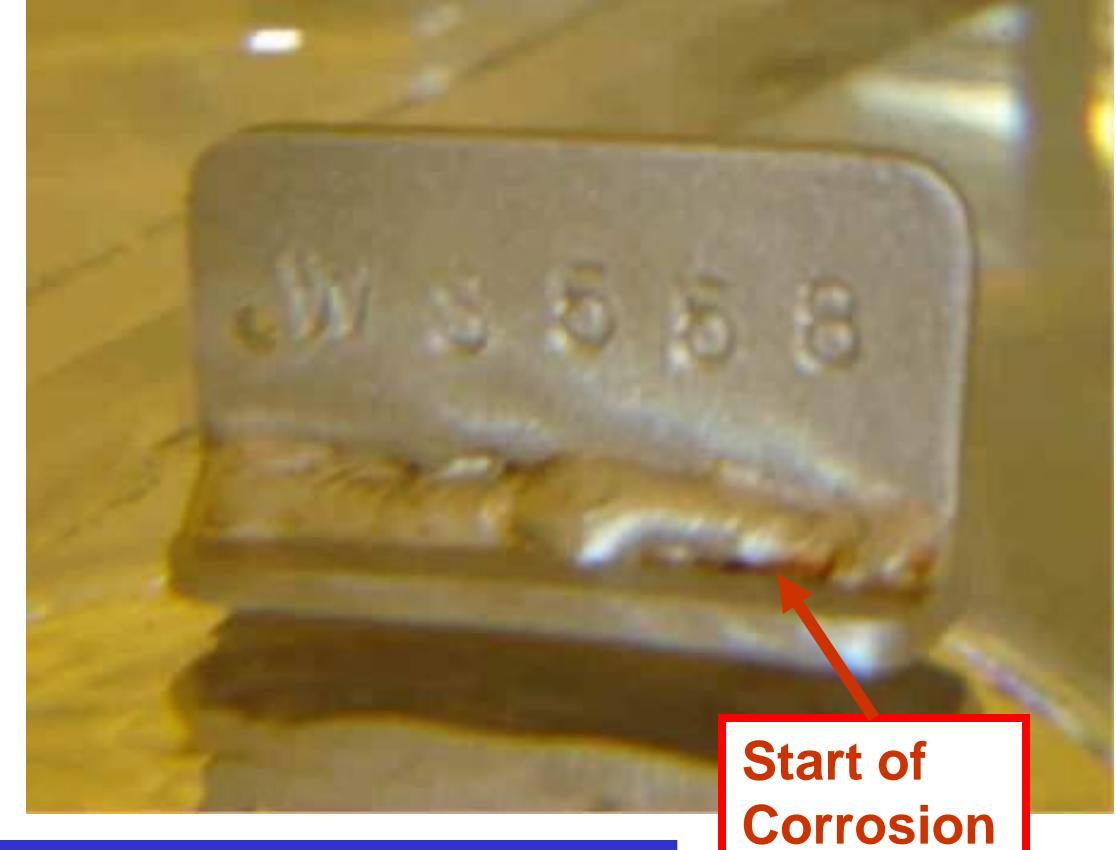
Effect of pH on Corrosion Near Weld vs. Metal Plate in Uninhibited UAN 32

- Put a welded A36 coupon in a flask at 50 C and constant pH and gradually lower the pH by air stripping out the NH3
- A clear "transition pH" is reached where corrosion visibly takes off
- This "transition pH" is much higher (i.e. reached sooner) in the weld zone (pH= 6.6) than the bulk metal (pH=5.75)

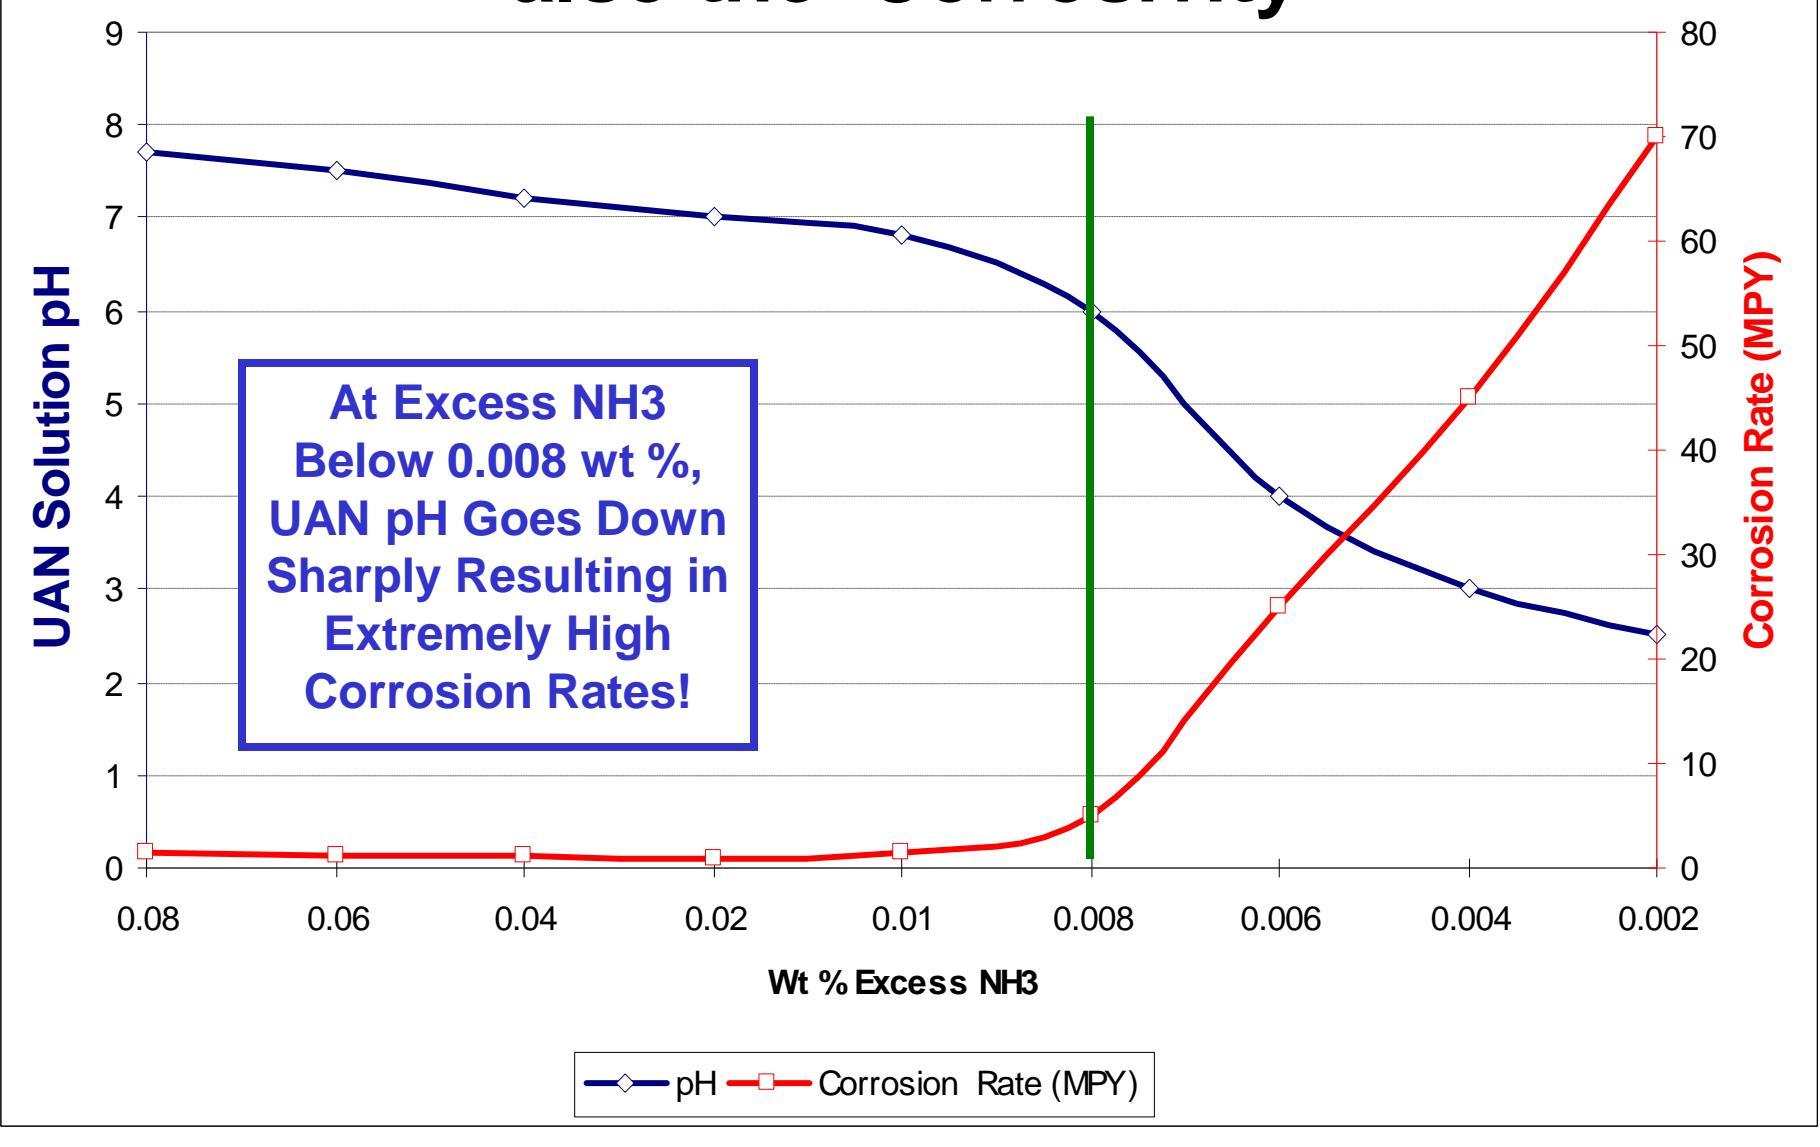
Excess NH3 Controls the pH and also the Corrosivity

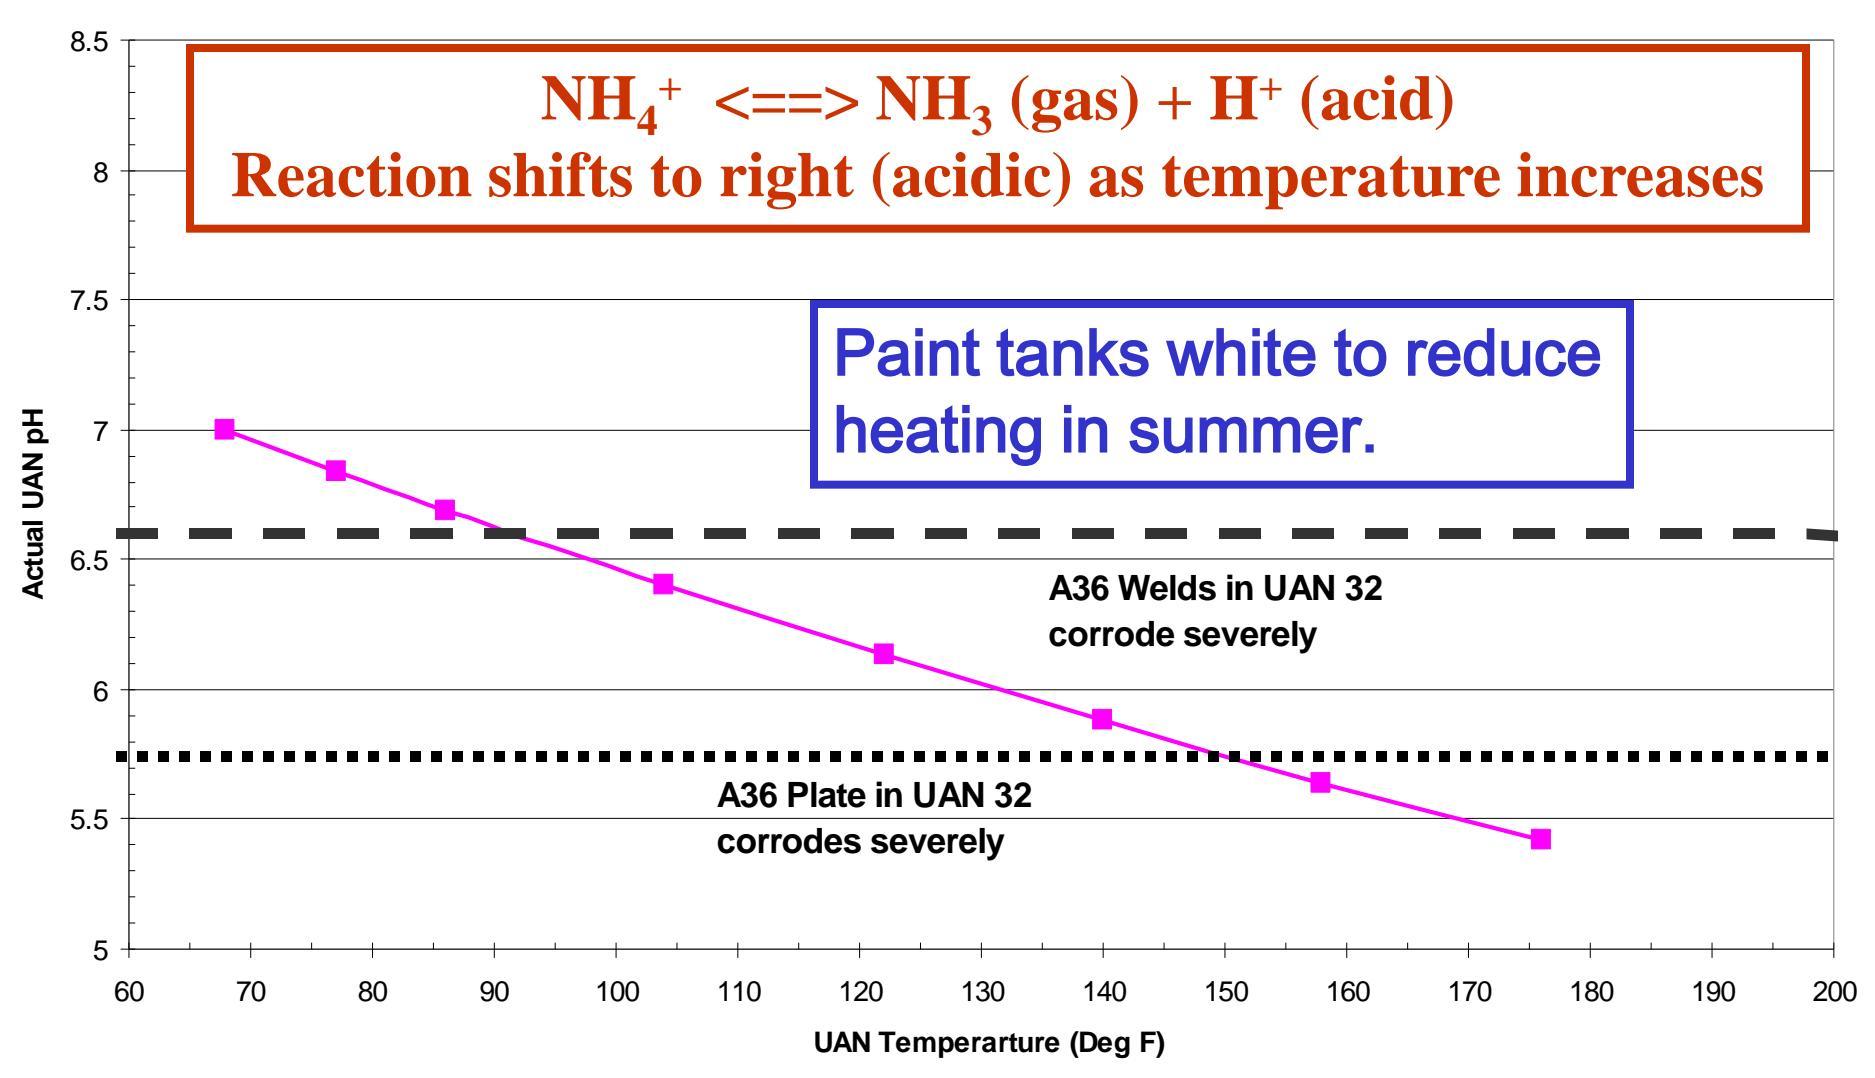
Effect of Temperature on Corrosion Susceptibility in Uninhibited UAN 32
