By Dr. Craig Myers, Senior Research Scientist and Phil Bureman, Industry Technical Consultant

Agenda

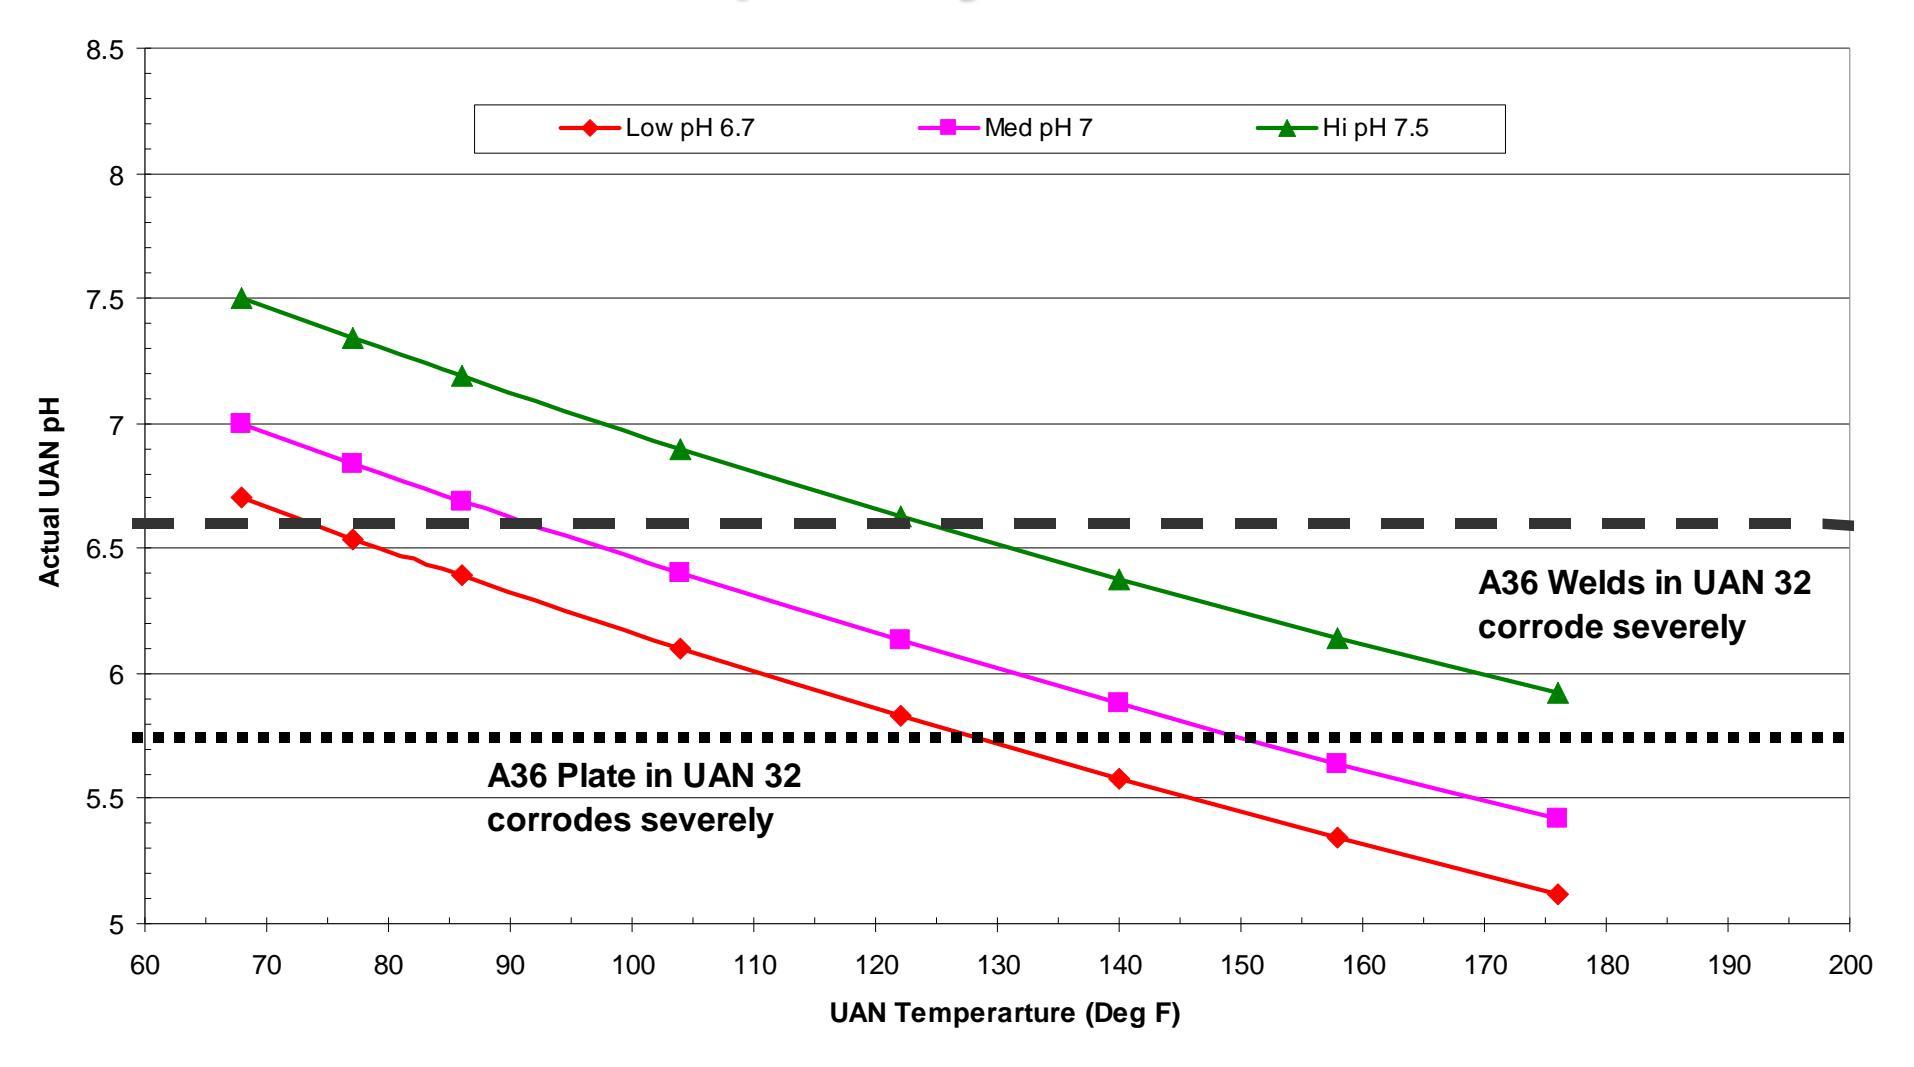
Effect of Excess Ammonia (Initial pH) on Corrosion Susceptibility in Uninhibited UAN 32

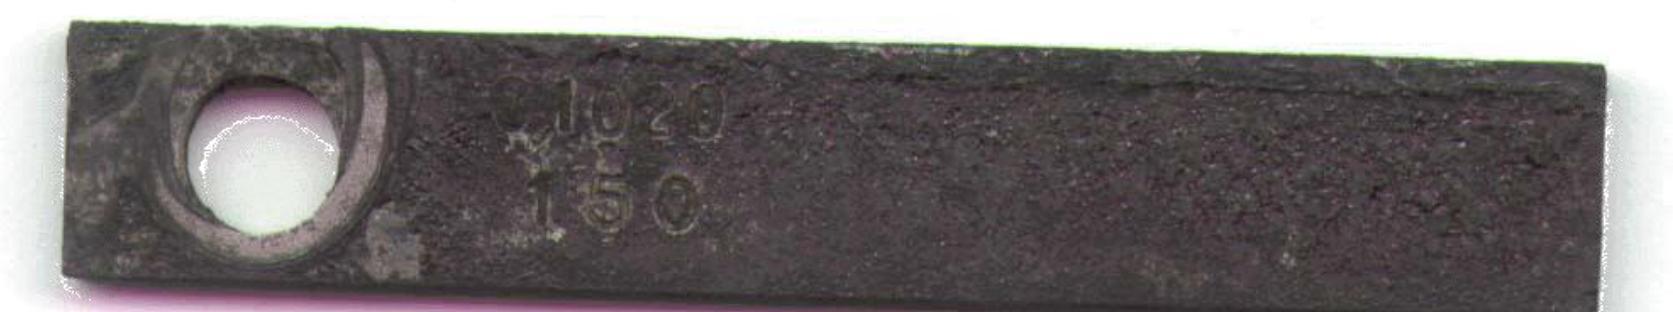
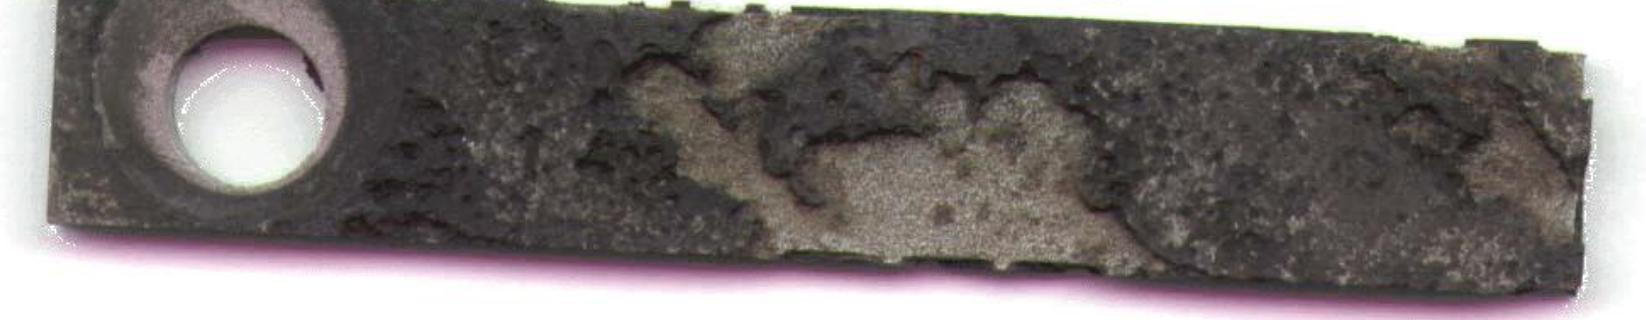
8 Days In UAN32 With % Excess NH3 @ 0.003 And Tank Temperature @ 150 Deg. F.

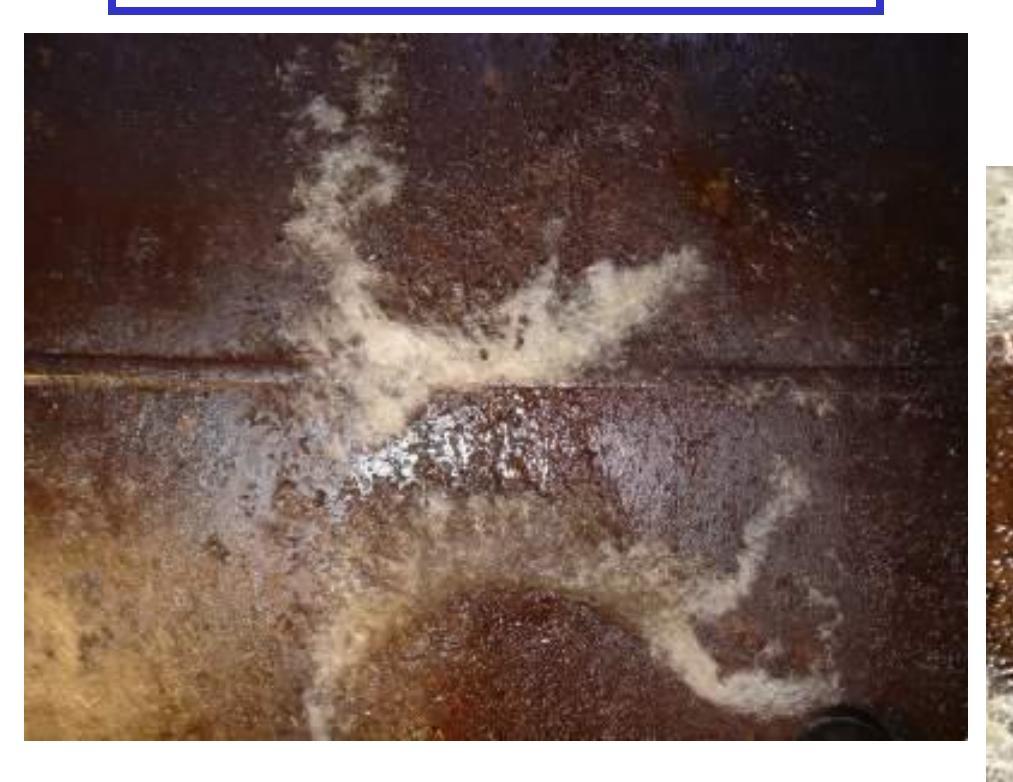
UAN salt deposit in a rail car

Close-up of salt deposit showing corrosion flake

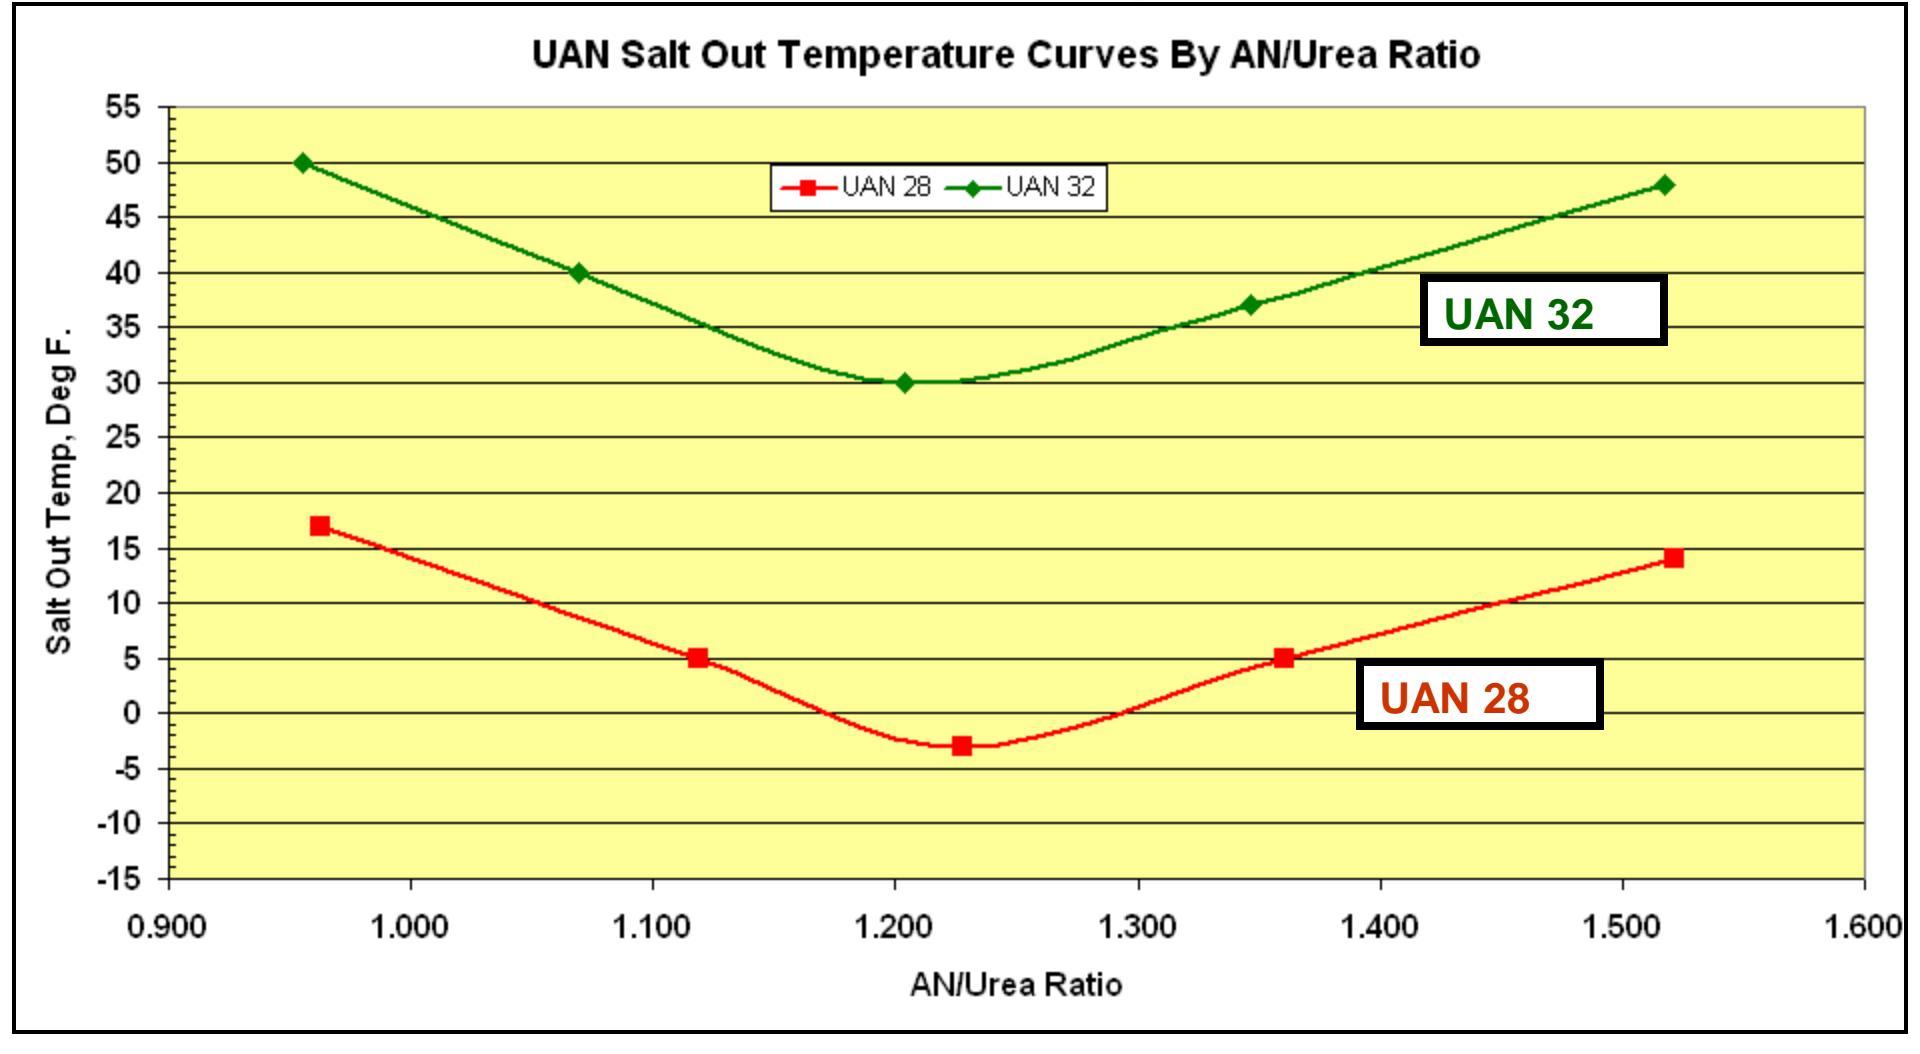
The Ratio of AN to Urea in UAN Determines the Salt Out Temperature

The ideal ratio range is 1.1 to 1.4

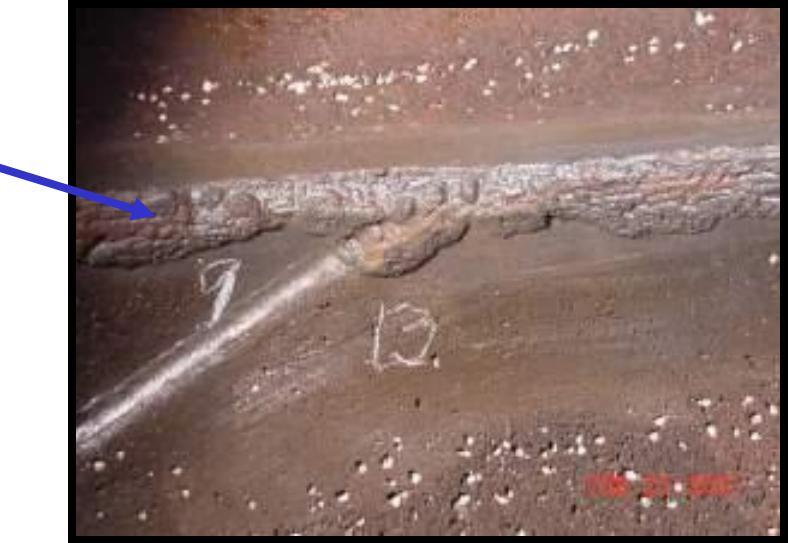
Grooving-type corrosion along a weld is typical of the influence of the HAZ

Proper welding techniques can help to minimize the residual stresses

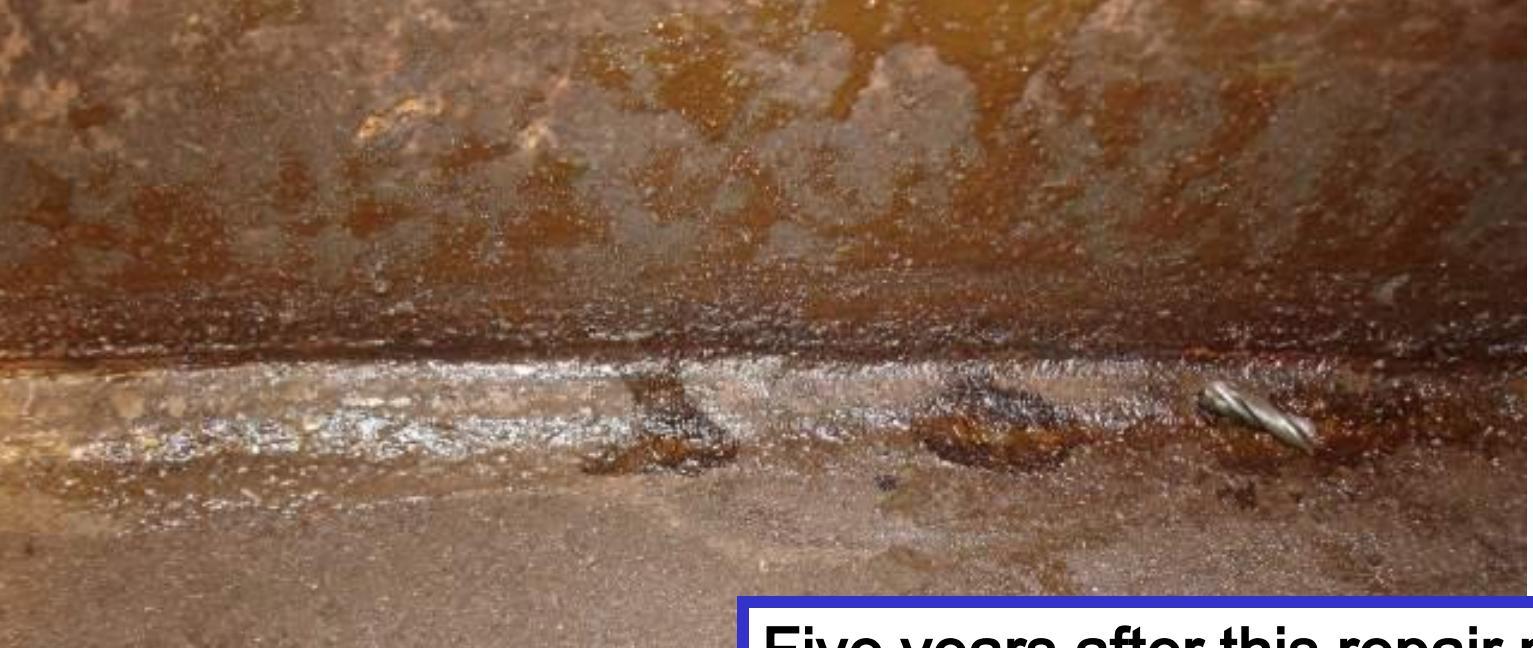
Faulty Repair Plate Installation

Five years after this repair plate was poorly installed on the tank bottom, a crack has appeared in the chine weld where the repair plate meets the tank wall.

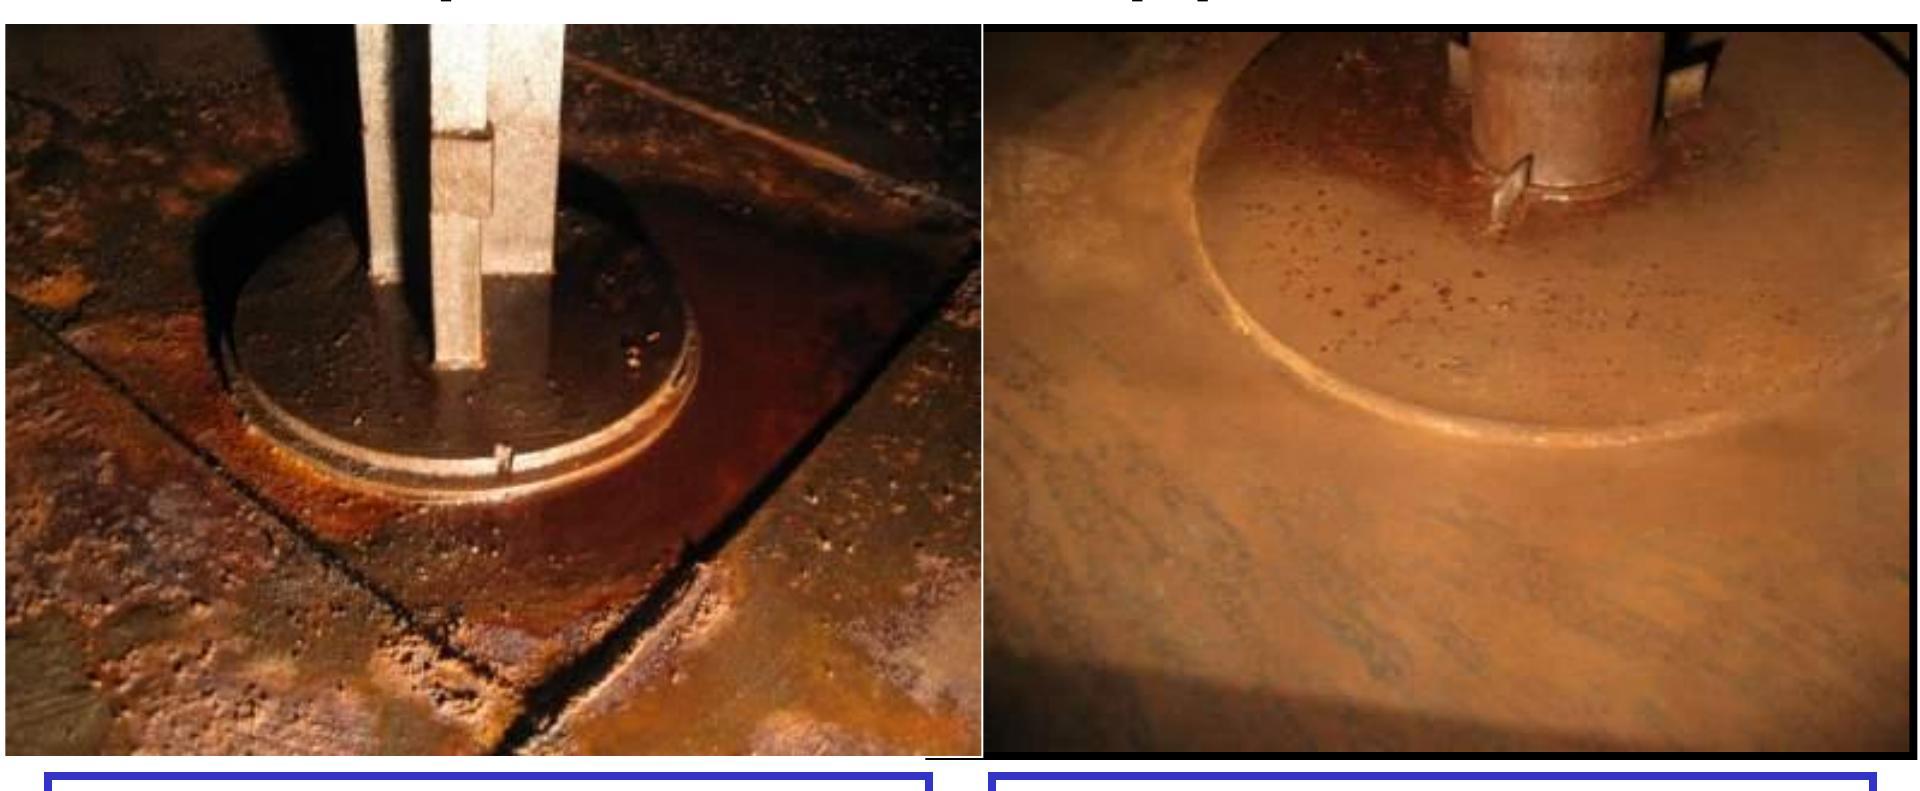
Comparison of Support Plates

Unusual Roof Support Plate

The roof weight is focused on a single small floor plate, lower than the main floor. Welds around this square plate were the only place significant corrosion took place. Typical Roof Support Plate The roof weight is spread across several plates and underlying strata. No unusual focus of corrosion observed.

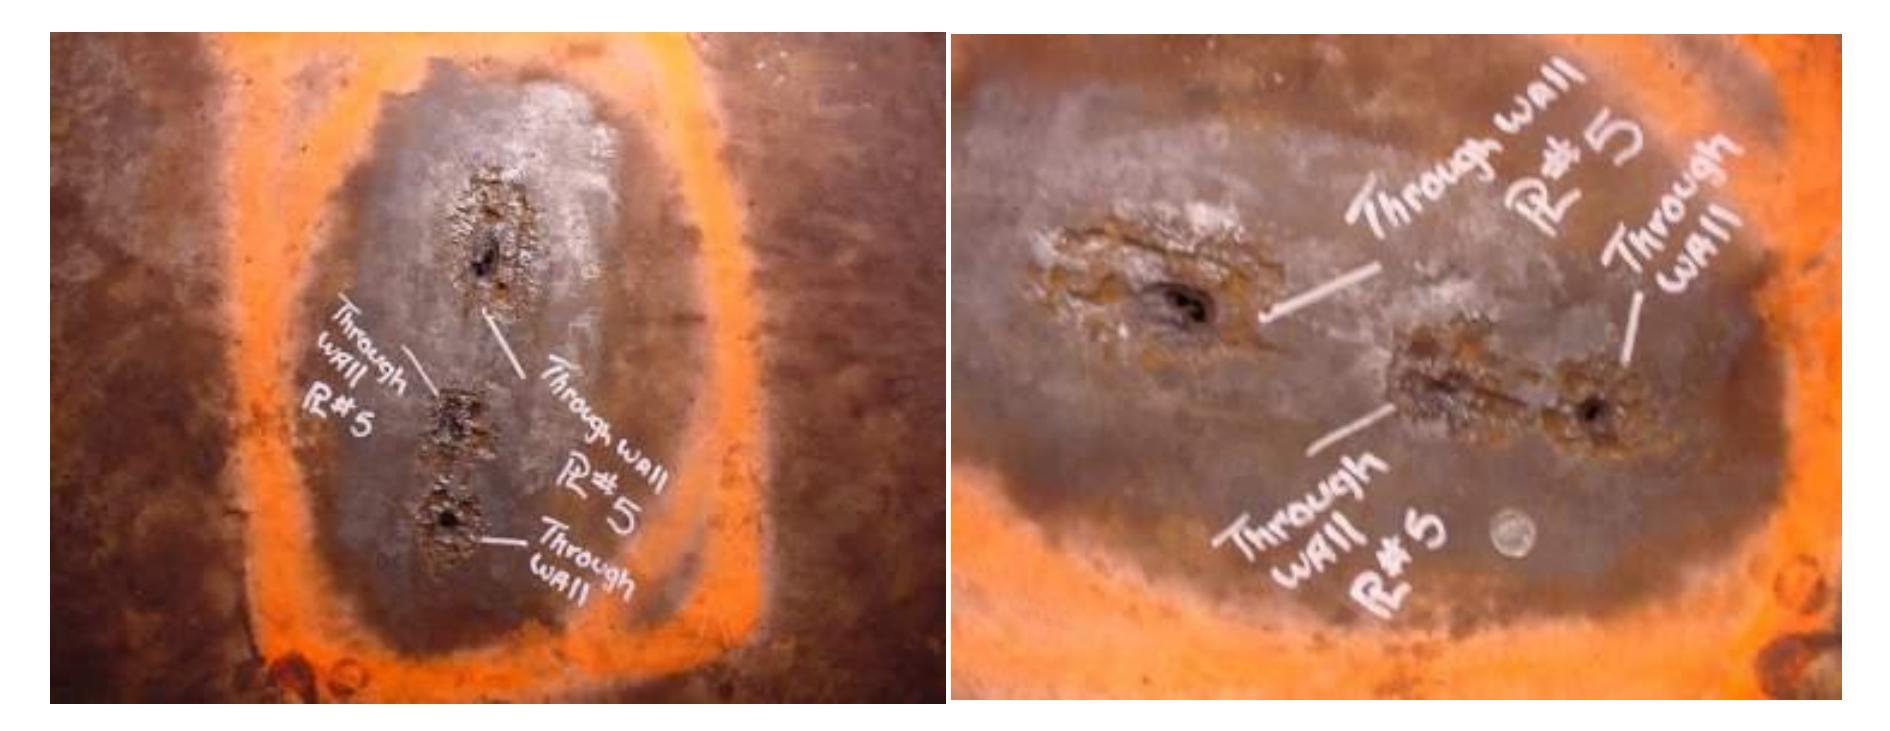
Corrosion at Compromised Metallurgical Site

Through Wall Pitting

Lifting lugs were removed from this plate by knocking them off with a sledgehammer. Perforation of the tank bottom occurred in 6 locations. Close Up of Through Wall Pitting Note how the corrosion practically drilled through the affected metallurgy.
